MAIN DESIGNS OF BRIDGE REPAIRS ON MAIN ROAD M-8 SECTION: ALJINOVIĆI – SJENICA – NOVI PAZAR

Slavica Vučetić-Abinun, Petar Spasić

The Highway Institute, Bridge Department, Serbia

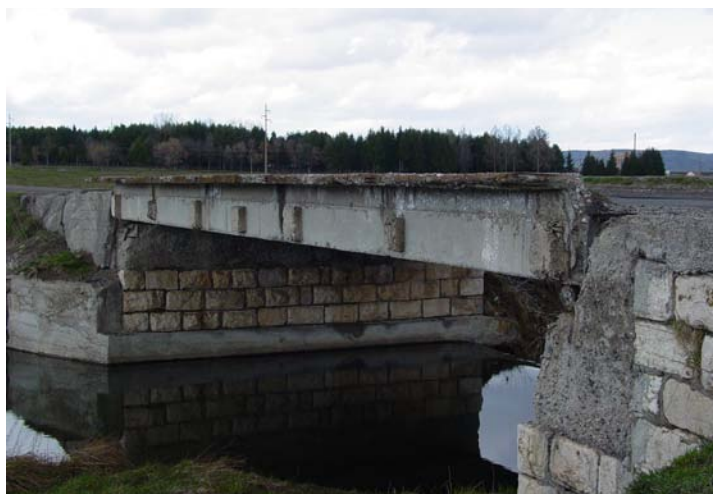
Figure 2 View of existing bridge

The last inspection of bridge structure was carried out in the year 2007. The conclusion was drawn, based upon computed bridge ratings, that this bridge required an urgent repair.

Taking into account that the waterflow fills up the entire bridge span profile which caused justified suspicion that the footings of extreme piers were exposed to scouring.

In view of the fact that concrete ground beam, due to the existence of cascade in bridge profile, is not leaning onto the bedding with entire surface, but "hanging" partly, called for suspicion as regards the abutments, and consequently on the stability of entire facility and traffic safety. Based on these facts and recorded deterioration in the structure, the Designer proposed to the Client as follows:

- to remove entire bridge structure;
- to build a new facility with required traffic profile which will fulfill all prerequisites of stability and functionality of the structure as regards security and traffic safety;
- to carry out stream diversion by river bed training upstream from the bridge; to renew the profile by river bed training downstream from the bridge; to perform the lining of river channel, all based on adequate water engineering documentation;
- to prepare design documentation for new facility based on horizontal and vertical elements of upgraded alignment of Main road M-8, geotechnical investigations and conditions, as well as on hydraulic conditions of bridge span for this specific location.

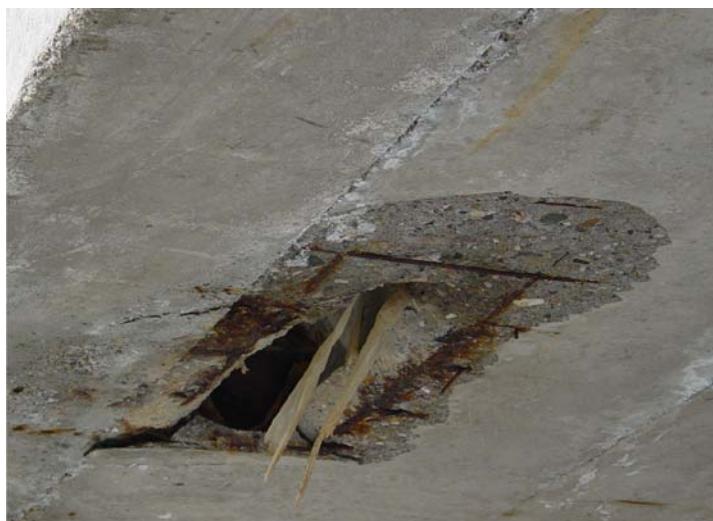
Figure 3 Pavement structure damage

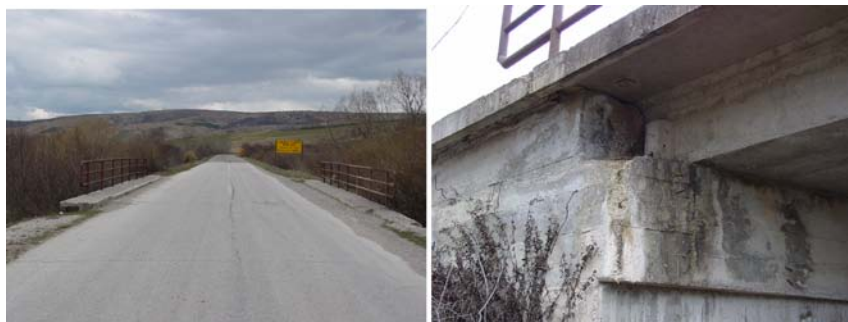
Figure 4 View of the bridge and water penetration through pavement structure

By structural analysis regarding the load bearing capacity of existing span structure for additional permanent loading (new elements of traffic profile) and imposed load (computed load scheme for typical vehicle V 600) one was in a position to obtain ultimate stress on the lower girder's edge $\sigma_1 = -7.51\text{ MPa}$. It was established that the allowable edge tensile stress under operation was exceeded, for concrete type MB 40 MPa, which amounts $\sigma_{bz, \infty} = -1.8\text{ MPa}$. Face surfaces of girders with shield concrete of tie-bars are in direct contact with the embankment materials, so through deteriorated pavement, the water and industrial salt are penetrating into the zone of girders' ends. This caused justified suspicion regarding the conditions of tie-bars, and thereby consequently on the conditions of cables' ends and size of prestressing force in cables.

- Substitution of bridge span structures;
- Reconstruction of support zones on abutments;
- Repair of existing head and wing walls of abutments
- Design documentation for the works thereof has to be brought into accord with horizontal and vertical elements of upgraded alignment of Main road M-8.

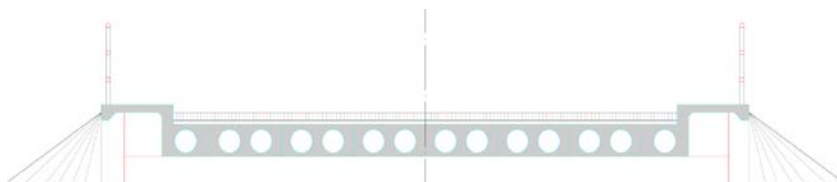
The deficiency of such structural system is represented by so called "dry" joint between main girders, thus preventing efficient transverse pulling-in, meant for interaction of all longitudinal girders.

Figure 5 Cross-section of existing structure

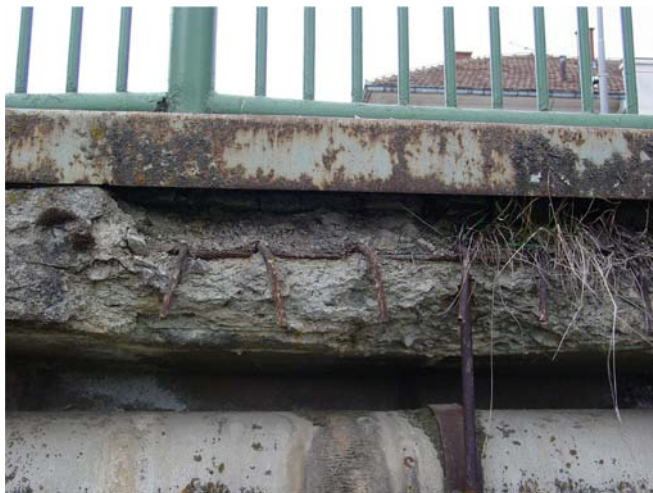
Figure 6 Reinforcement corrosion on pathway cantilever

Concrete at the end of cantilever of pathways is damaged by the impact of atmospheric water and industrial salt, reinforcement is denudated and corroded. There are no drip channels, so that the water from stair treads is penetrating into and wetting the lower surface of cantilevers. Steel profiles whereupon the installations have been hung corroded as well.

- Repair of pavement slab cracks by grouting,
- Repair of concrete surface damages due to penetration of water and salt through pavement slab,
- Repair of corroded reinforcement,
- Preparation of protective coating (preservatives) on concrete structure surfaces,
- Design of temporary road and vertical signs provides for the repair works, on the bridge over Grabovica river, to be carried out in two phases, by alternating closure of right and left pavement lanes.

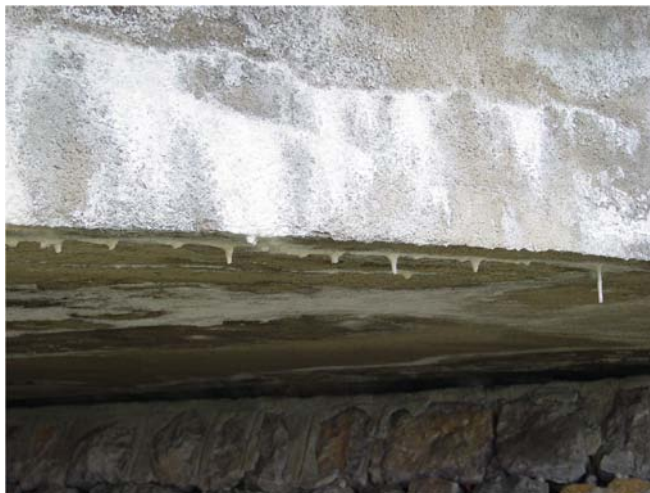
It was established that there were calcification traces of water penetration on head carcass of abutments, through pavement slab. Due to the damage of water-supply pipe and permanent wetting of its structure, the separation of abutment stone cladding and washing out of terrain behind the abutment appeared.

On lateral surfaces of pavement slab there are white, calcified spots originating from aggressive impact of water and salt, as well as “stalactited” formations. On the bottom side of main girder - sheeting rail there are also visible calcified spots, partly damaged protective layer of concrete, whereas denudated reinforcement corroded.

Figure 7 Calcification due to water penetration through the structure
