THE MOST COMMON CAUSES FOR FASTER DETERIORATION OF BRIDGES

Krunoslav Mavar, Sandra Škarić Palić, Jelena Bleiziffer

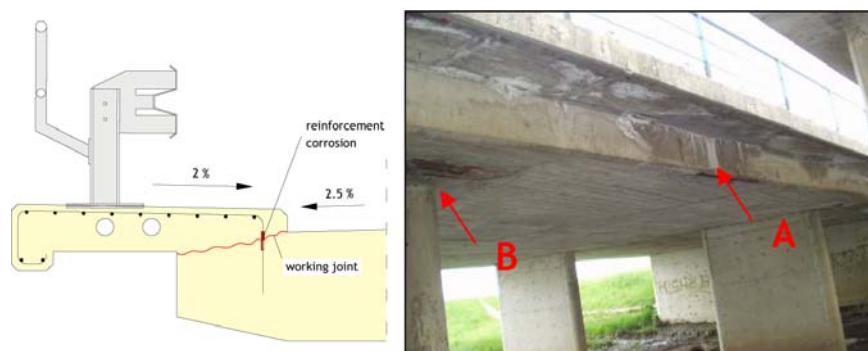
Figure 1 Cross section of the cantilever and deck slab edge with marked working joint and location of reinforcement corrosion; Photograph: A-water penetration through working joint, B-leaking underneath gully [1]

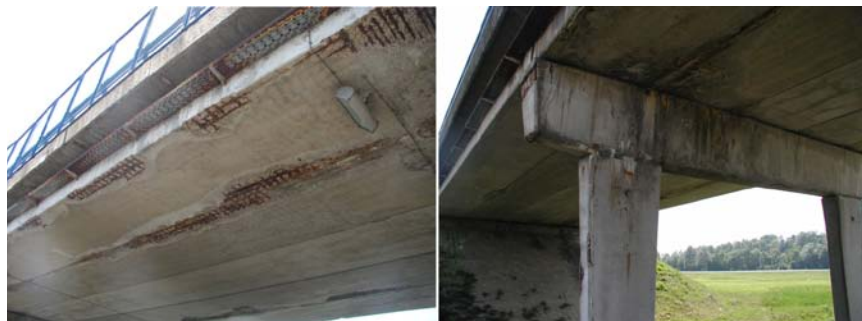
Figure 2 Overpass junction 'Ivanič Grad' on highway Zagreb-Lipovac: severe reinforcement corrosion and leaking [2]

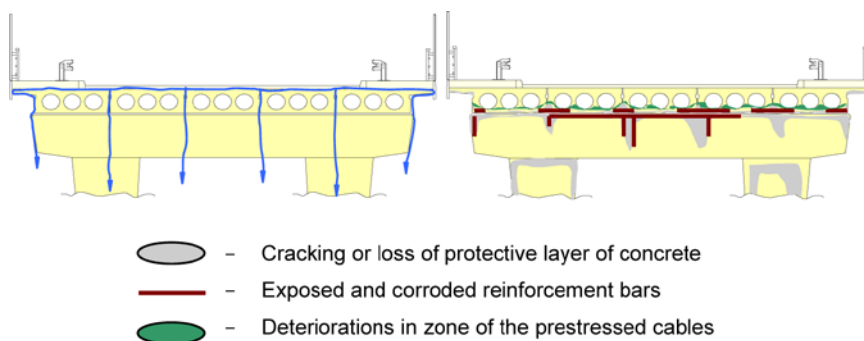
Figure 3 Cross-section of overpass with marked ways of water penetration on girders, head beams and all elements of the substructure(left) and areas with characteristic deteriorations(right) [3]

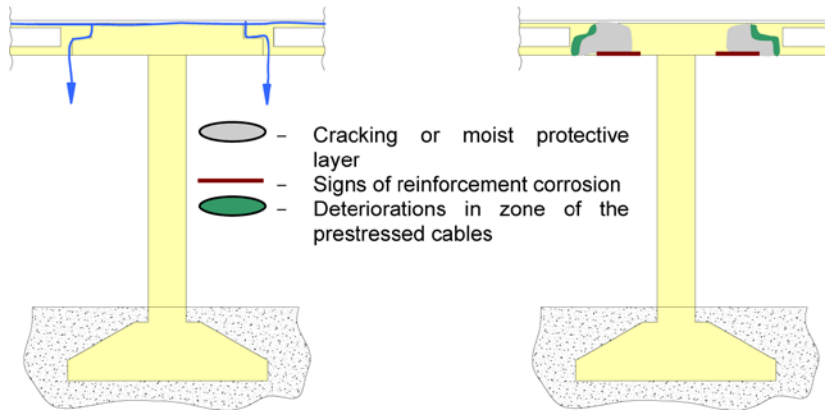
Figure 4 Marked ways of water penetration on the support areas, and deteriorations on these locations[3]

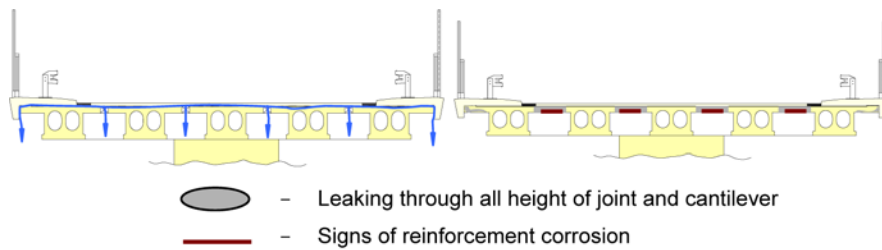
Figure 5 Cross- section with marked ways of water penetration (left) and deteriorations due to water ingress through joints (right)[3]

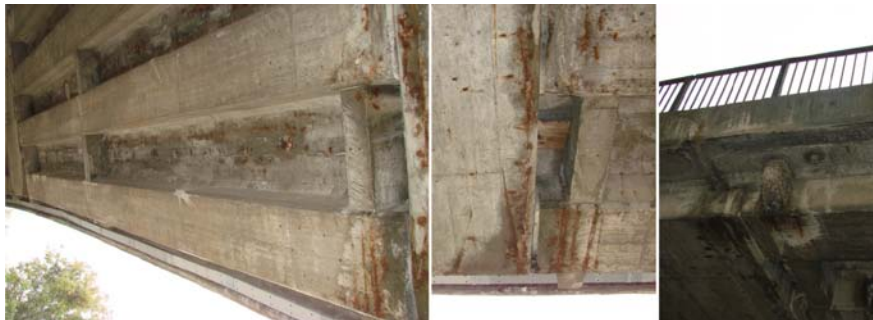
Figure 6 Leaking through longitudinal joints; signs of ongoing corrosion on cantilever head beams and heads of girders; heavy leaking through transverse joints on the support area on Overpass in junction Lučko[2]

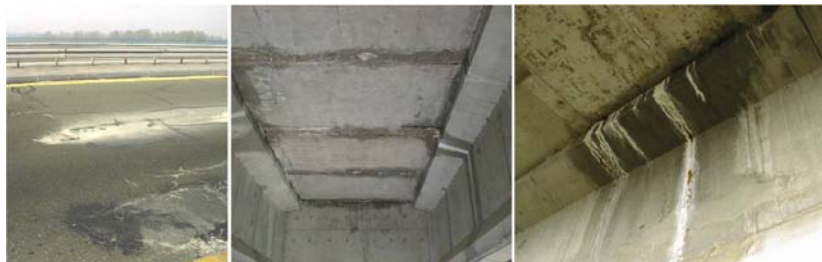
Figure 7 Disintegration of levelling course concrete which is seen on asphalt surfacing, leaking through transversal joints of deck slab and over edges, and leaking on main longitudinal girders[4]

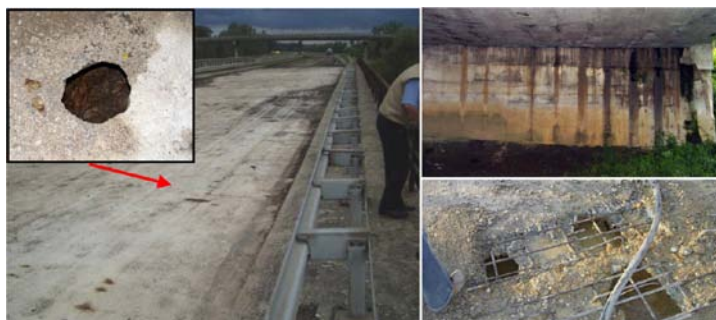
Figure 8 Visible wholes after removing asphalt surfacing and waterproofing, leaking on abutments through all 12 deck slab voids, after removal of levelling course concrete is sipping into voids[4]

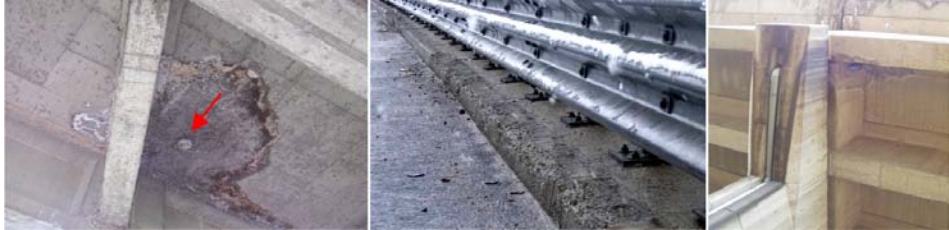
Figure 9 Leaking around whole left from formwork, degradation of concrete curb, leaking around drainage system on head beam
