EFFECT OF BALLAST POCKETS ON DECREASE IN BEARING CAPACITY AND STABILITY OF GEOTECHNICAL RAILWAY STRUCTURES

Pero Šiša, Željko Sokolić
Geotehnički studio d.o.o., Croatia

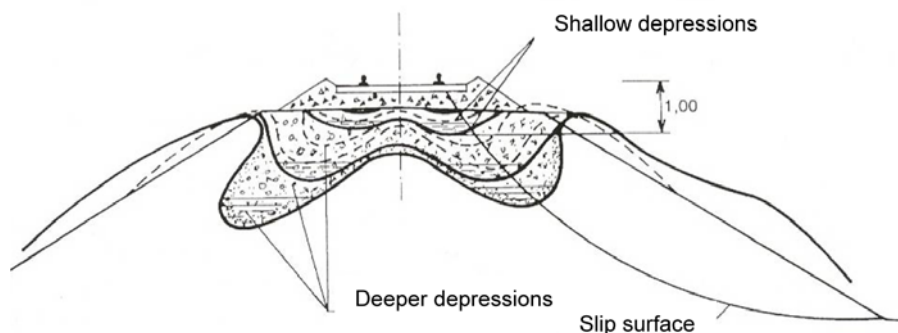
the embankment core (Fig.1.). Depending on mechanical characteristics of clay in bedding, quickness of impressing crushed stone material from subballast and from ballast is different. In a clayey bedding, firstly smaller bodies are formed known as smaller pockets, which in time increase and turn into shapes called depressions, while in the last phase of genesis bigger bodies are formed, so called ballast pockets.

Figure 1 Ballast depressions and their genesis

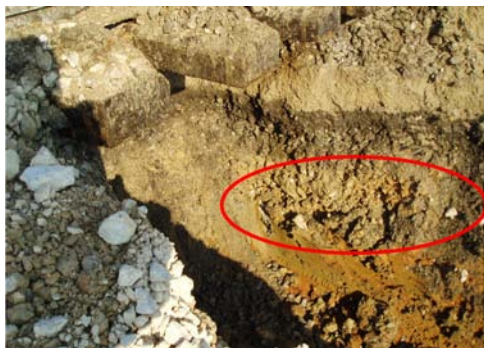
By impressing, stone material is mixed with clay. Newly created material (Fig.2.) is of different grain size distribution, more permeable, saturated with water and with significantly lower mechanical characteristics compared to the bedding clays and subballast underneath. By the increase in the ballast pocket volume, surface that providing shear resistance to shear stresses consists of two parts:

Figure 2 Ballast pocket material

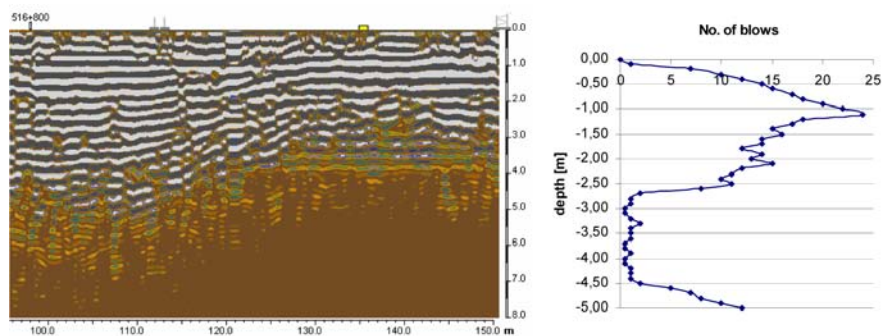
Combination of destructive and non-destructive methods of investigations is applied for purposes of detecting position and size of ballast pockets. By georadar (GPR) measurements (method applied on our railways since 2002.) continuous longitudinal profile of the recorded track line is obtained, while on positions with potential instabilities further investigations are carried out (excavation of investigation pits, dynamic probing, drilling investigation boreholes). Figure 5. shows an example of investigation results of GPR method and DPH probing of embankment fill. Longitudinal GPR profile indicates existence of ballast pocket of more than 4m in depth, while DPH profile indicates significant resistance reduction in the very zone of ballast pocket existence.

Figure 5 GPR and DPH profile

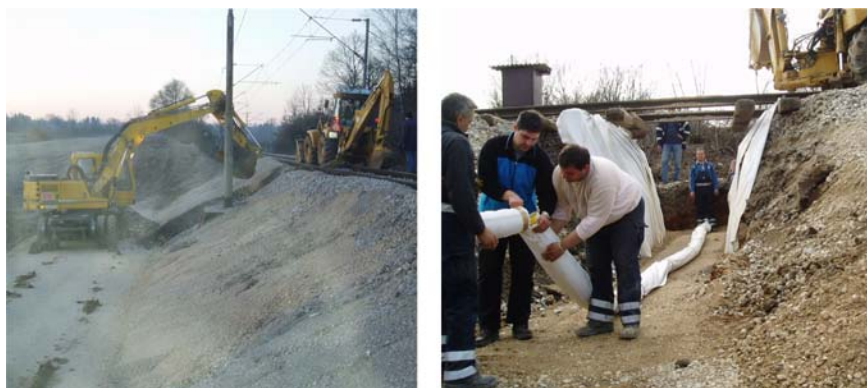
Figure 6 Execution of transversal drainage ribs

Shown is the importance of interventions before last phase and failure occurrence or, if the process is started, as soon as it is detected. Usual improvement mode of railway sections affected with destabilization comes down to execution of excavations perpendicular to railway axes, in conditions of traffic shut down. In these excavations, replacing existing with drainage gravel-stone material is carried out, captured water is drained and extracted from the embankment (Fig.6.). While conducting these works, special wagons for material transport and trench excavators are used.

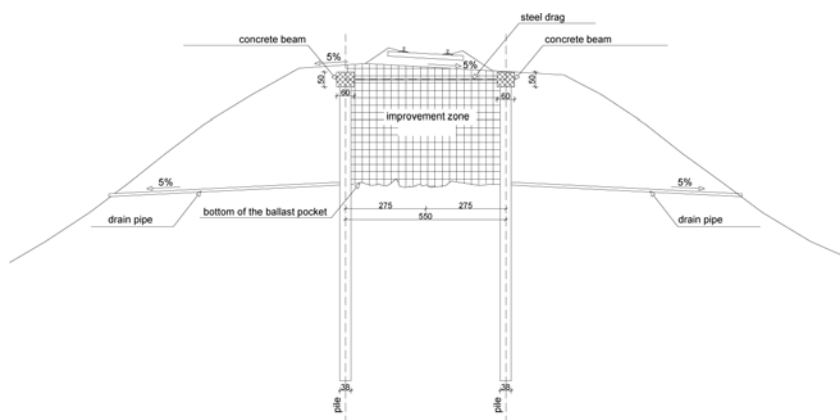
Figure 7 Cross section of the ballast pocket improvement measures on the embankment Donje Dubrave

On the embankment at Donje Dubrave, due to its height, drainage load bearing rib wasn't applicable, so the improvement solution was to be found in making a ballast pocket material composite (grouting, "mixed in place",...) and draining the material of the ballast pocket, respectively, construction of the new embankment since the existing one was in the curve. Besides constructing new embankment in controlled conditions, this would improve elements of the track alignment (larger curve radius).

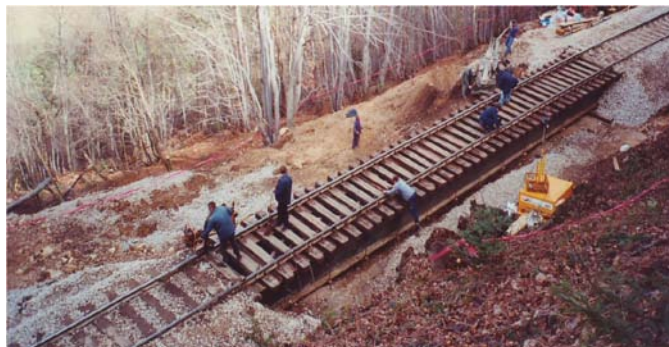
In cases when this process is not identified on time, unwanted consequences can occur as it was the case on the locality of Plavča Draga. Frequent tamping of railway tracks maintained railway's vertical alignment line. After unfavorable hydrological conditions (sudden snow melting) deformations accelerated leading to failure. Traffic was shut down for 4 days. In this

Figure 8 Temporary improvement measure

period preliminary geotechnical works have been carried out and temporary construction was set up (steel provisory) (Fig.8.), founded on piles of small diameter. After restoration of traffic, investigation works and selection of the permanent improvement solution was continued with. As optimal permanent improvement solution, reinforced soil structure was selected.
