SEISMIC RETROFITTING OF THE GROMOVI BRIDGE IN SISAK

Marijan Skazlić¹, Slobodan Lavrnić², Željana Skazlić², Mario Vujica², Klara Panadić²

²Geoexpert – I.G.M. d.o.o., Croatia

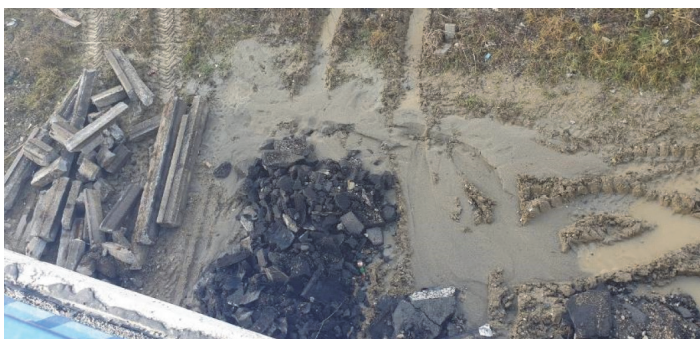
Figure 3 Sand extrusion from a soil crack near pier S4 [2]

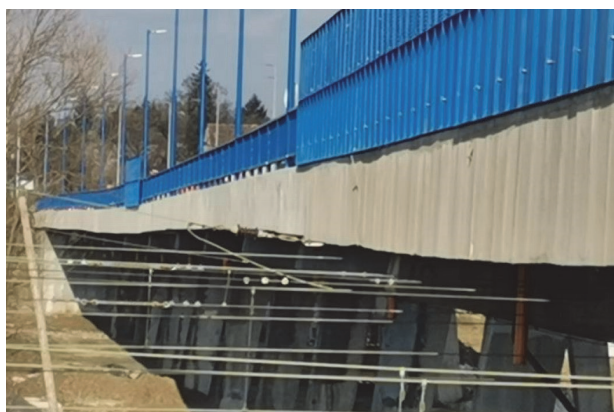
Observing the western side of the northern viaduct, a level difference in the viaduct superstructure was noted (figure 4). Geodetic leveling measurements were conducted to compare the current state of the structure with a leveling survey carried out before the earthquake. Since the absolute displacement could not be determined due to the lack of a permanent reference point, the maximum relative vertical displacement of the leveling line between abutment U2 and pier S6 was measured at 17.7 cm [2, 3]. The geodetically determined displacement of 17.7 cm significantly exceeds the limit value specified in Eurocode 7, where the total settlement of a statically executed structure must not exceed 10.0 cm [3]. Accordingly, reference points (benchmarks) are installed on abutment U1 and piers S2 to S5, allowing spatial geodetic monitoring of potential further displacements at two points on each element in the event of future earthquakes or high water levels of the Kupa River [2]. The benchmarks are installed 1.0 m above the foundation and 1.0 m below the pier cap [3]. Analysis of the measurements over a period of approximately 3.5 months showed that the largest settlement on the northern side of the bridge occurred beneath the right foundation of pier S5, measuring 0.81 cm, while the largest settlement on the left side was observed beneath the left foundation of pier S21, measuring 0.24 cm [3].

Figure 4 Differential settlement of the AB span of the northern viaduct resulting from pier settlement (S2–S6) due to seismic ground movement [2]

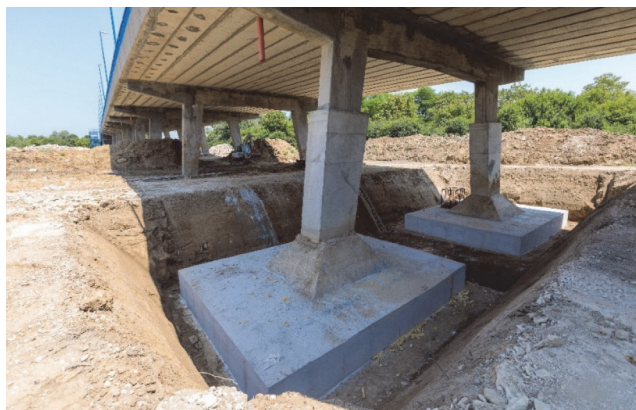
Figure 5 Widening and strengthening of bridge piers

Reinforced concrete collars with a height of 1.0 m were constructed around the existing foundations, providing an extension of 0.5 m from the edge of the existing foundation, as well as a 0.5 m layer above the footing and around the truncated pyramid (figure 5). The damaged concrete layer was removed using hydro-demolition, while the existing reinforcement was coated with a protective anti-corrosion treatment and any deteriorated bars were replaced. Bonding between the new and existing concrete was achieved by anchoring Ø12 mm reinforcement bars at 30 cm spacing into pre-drilled Ø16 mm holes, 20 cm deep, previously filled with epoxy resin [2].

Hydro-demolition was used to remove a 2-3 cm-thick layer of concrete from the piers up to 4.0 m above the foundation level. The existing reinforcement was coated with an anti-corrosion treatment, and any damaged bars were replaced as required. A 20 cm-thick reinforced concrete overlay was constructed around the existing piers, forming a rigid connection between the pier and its foundation (figure 5). The longitudinal reinforcement of the jacket was anchored into the existing foundation using pre-drilled holes filled with epoxy resin. The anchorage length of the $\varnothing 20$ mm longitudinal bars was 100.0 cm. This intervention resulted in a change of the structural system, replacing a pinned connection with a fixed connection [2].
