CHALLENGES IN RECONSTRUCTING STATE ROAD DC101 IN CROATIA

Ante Barišić¹, Ana Čudina Ivančev², Vesna Dragčević², Tamara Džambas²

¹TRG d.o.o., Croatia

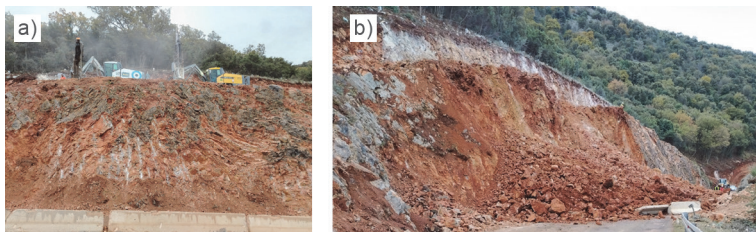
Figure 2 Excavation by drilling and blasting: a) drilling of anchors and boreholes, b) result of the first blast

The initial blasting was the most demanding and resulted in the separation of a large rock mass that covered the entire road, as shown in figure 2. Subsequently, the blasting parameters were adjusted by reducing the number of explosives, resulting in more moderate breakages and reducing the risk of prolonged road closure. Due to the identified instabilities, particularly in areas affected by seepage breccias, rehabilitation and slope protection measures are planned.

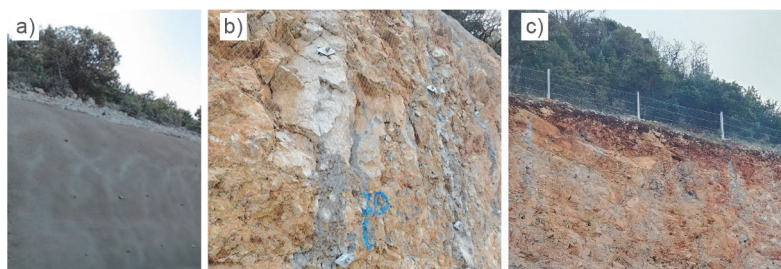
Figure 3 Protection on slope: a) type 2, b) modified type 3, c) rockfall protection barrier

The designed solution included three types of slope protection: (1) hexagonal double-twisted wire mesh, (2) self-drilling anchors and shotcrete, (3) hexagonal mesh reinforced with anchors and steel cables. Of these, only type 2 protection was applied as designed on sections with increased landslide risk. This method combines deep anchoring with surface protection using shotcrete, achieving slope stabilisation and preventing the shedding of surface material and the erosive effects of atmospheric influences. To reduce costs and accelerate the work schedule, a modified type 3 protection was implemented, in which, instead of installing steel cables, the mesh is fixed using base plates and nuts on the anchor rods. Compared to the originally designed type 3 slope protection, the modified type 3 protection allowed for faster execution and simplified organisation, while maintaining satisfactory system functionality. The combination of active stabilisation with anchors and surface retention with mesh ensures long-term slope stability and road safety.

Rockfall protection barriers are an active measure to protect the road from falling large stone blocks and material shed from the natural terrain above the slope. Unlike protective nets, which passively retain smaller rock fragments from the slope, barriers serve as a physical barrier to larger broken blocks, thereby protecting the road, vehicles, and road users. The high slopes along part of the route required additional safety measures, and debris protection barriers provided effective protection for the road and all users. Figure 3 shows the types of protection implemented.

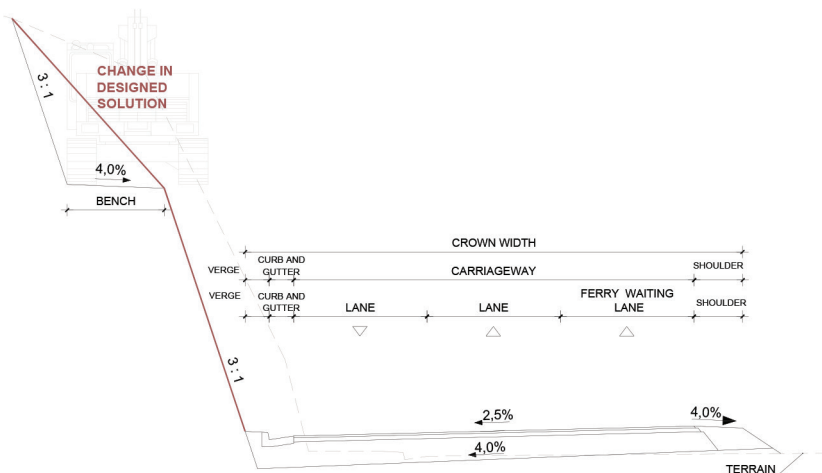
Due to insufficient space for the excavator, it was decided not to construct the bench at a height of 6 m and a width of 2 m. Instead, a gentle slope was formed for the cut. This altered the project design and accelerated the execution of the works. The change in the design is shown in figure 4.

Figure 4 Change in cut slope

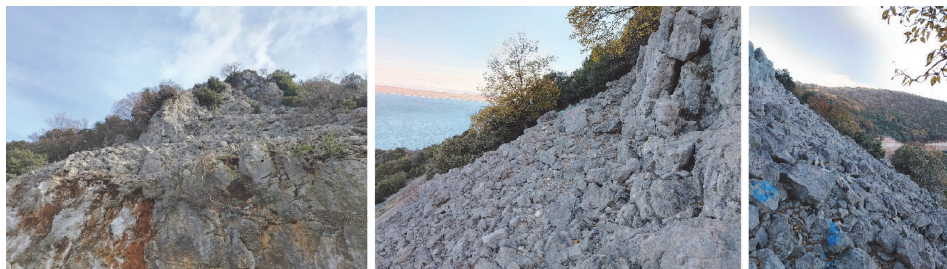
Rehabilitating the rockslide was the greatest challenge during reconstruction. The rockslide was located outside the project boundary and was therefore not included in the design. Several field solutions for rehabilitation were considered. The first option was to install an energy barrier to intercept the activated blocks of rock mass before excavation. However, at the top of the slope, there were 1 to 2 m of accumulated rock blocks, probably fallen from the rock (figure 5). Because of this, energy barriers and anchors would not function as intended. The second option was to create a 5:1 slope on the cut without a bench, at a height of 6 m. This intervention would require entering loose material composed of separate blocks, which would endanger safety and pose a risk to the movement of people and machinery immediately below the slope.

Figure 5 Accumulated rock blocks

Therefore, the chosen solution was to construct a ramp to provide access to the top of the slope and to remove unstable material. During ramp construction, additional hazards were identified, so an auxiliary serpentine ramp was built from the existing platform. Unstable rock blocks were removed and broken up from this ramp. For traffic safety, a physical traffic stop was implemented after each ferry departure. This was necessary because, during the work, rock blocks fell onto the road, damaging and passing over the New Jersey-type concrete barriers (figure 6).

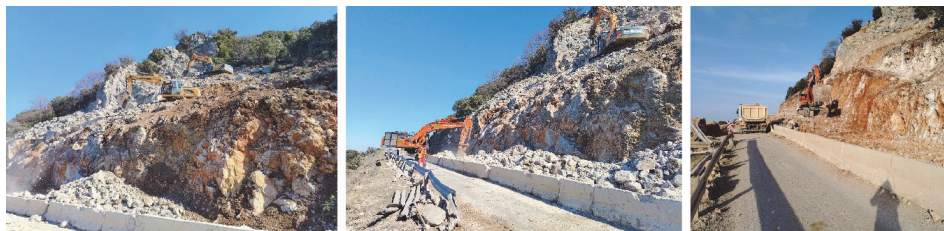
Figure 6 Work on ramp construction

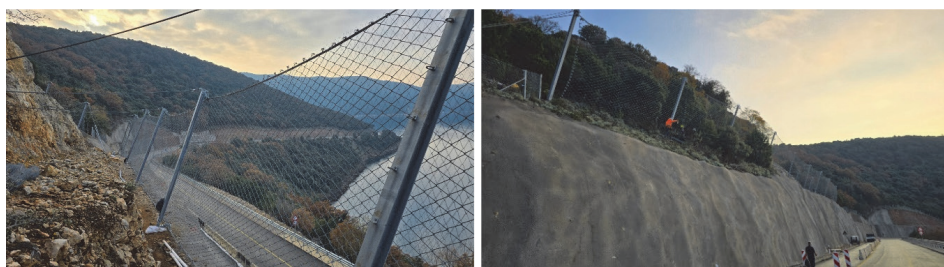
Figure 7 Energy barrier

After constructing the working plateaus and removing unstable blocks, the lower level of the slope was excavated at a 5:1 gradient, with a cutting height of approximately 8 m. Excavation was carried out using drilling and blasting methods. An additional design solution was implemented to provide slope protection type 2 (anchors, reinforcing mesh, shotcrete) and to install an energy barrier with a capacity of 2000 kJ, 5 m in height and 90 m in length, set at an inclination of 80 degrees (figure 7). This example shows that challenges arising at the site are often impossible to predict through design solutions. The implemented solution ensures long-term protection and stability of the roadway, with the constructed working plateaus serving as benches to stop possible rock blocks, and the installation of the barrier providing ongoing protection for the roadway.

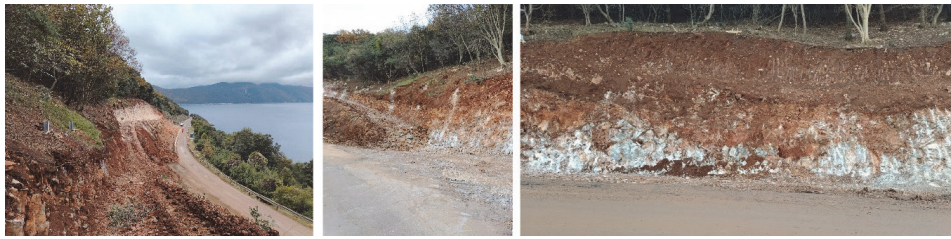
The landslide occurred in the border zone between Lower Cretaceous and Upper Cretaceous limestones, and rehabilitation was carried out on a section slightly less than 30 m long (figure 8). The design solution involved replacing the bedding material and constructing supporting gabion walls in the embankment. However, it was found that further measures are required to rehabilitate the cut.

Figure 8 Landslide

The rehabilitation involved removing soil to a depth of 2 m below the slope face, down to the rock base, to provide a quality foundation for the reinforced concrete beams. The works began with the installation of two layers of shotcrete, with a Q188 reinforcing mesh placed between them. Following this, IBO anchors with a diameter of 51 mm and a length of 9 metres were installed. The upper anchors were drilled and injected first, while the lower anchors, with a length of 6 metres, were installed after the beams were placed, through pre-prepared openings. The beams were placed vertically, each with two holes for anchoring, with cross-sectional dimensions of 0.40 × 0.60 m and lengths ranging from 2.5 to 5 metres. Fourteen reinforced concrete beams were installed to ensure the stability of the landslide and prevent further movement of the terrain (figure 9).

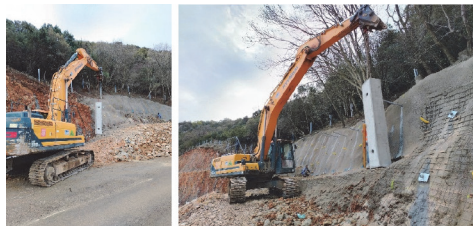
Figure 9 Placing beams on previously constructed anchors
