IMPACT OF FLOODING ON BRIDGE CONDITION: INSIGHTS FROM TWO CASE STUDIES

Abstract

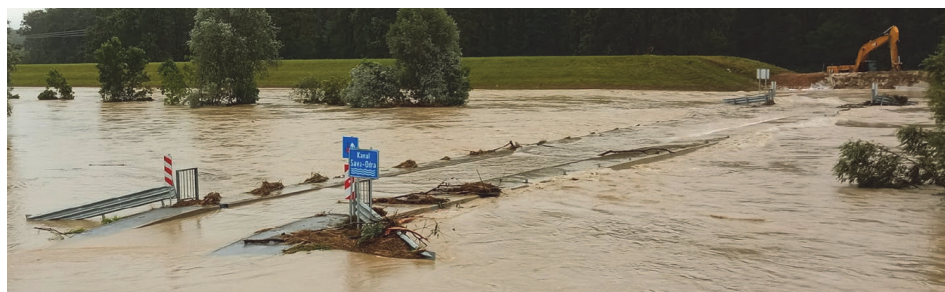
In August 2023, severe storms affecting the City of Zagreb and a significant rise in the water level of the Sava River led to the activation of the Sava–Odra relief channel, over which the Kučki Bridge is located. As the bridge elevation is lower than the depth of the channel, nearly the entire structure was submerged during the flood event (figure 3). After the water level receded, damage to the barrier and soil erosion on the embankment of the bridge were observed. Rehabilitation works were carried out, including repair of embankment and replacement of the asphalt pavement on the bridge, as well as removal of the damaged steel safety barrier and installation of a new one to ensure traffic safety.

Figure 3 Kučki Bridge during high water levels of the Sava River in August 2023

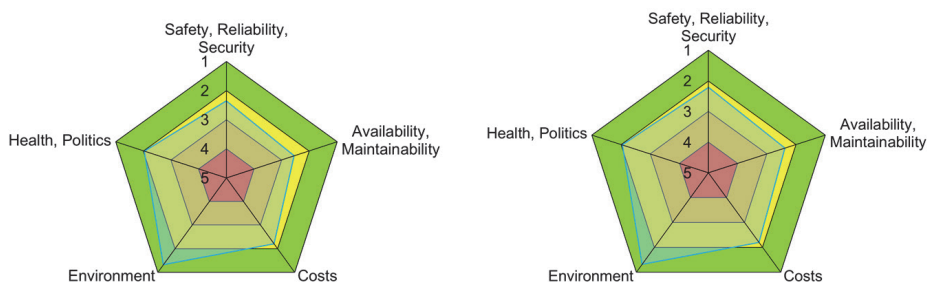
Figure 4 KPIs assessment for Kučki Bridge with (left) and without (right) flood risk [1]

The performance of the Kučki Bridge was evaluated using a multi-criteria KPI framework [4] structured into five groups (figure 4). Within the KPI safety, reliability, and security, the total rating of 2.36 indicates a borderline but stable structural condition, primarily influenced by environmental exposure, moderate deterioration of the concrete cover, and medium corrosion probability derived from electrical resistivity testing. The second and third KPIs, addressing availability and maintainability (2.55) and costs (2.21) highlight the impact of irregular maintenance and environmental aggressiveness on long-term performance and lifecycle expenses. In contrast, the Environment KPI achieved a favourable score of 1.32 due to low traffic intensity and effective drainage containment, while the health and politics KPI (2.04) reflects moderate strategic importance and the need for more systematic maintenance [1]. If the flood risk were excluded, the KPIs for safety and maintainability would be reduced by 6%, while other KPIs would remain constant.

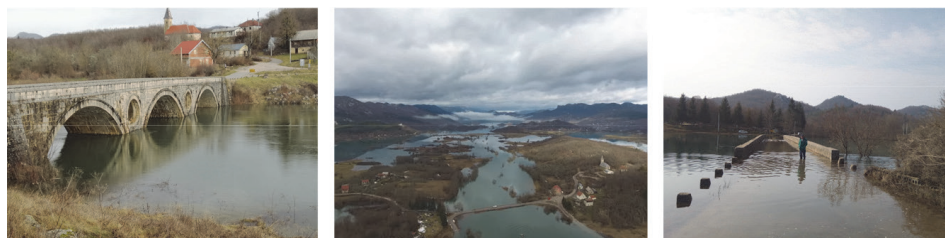
The Kosinj Bridge was damaged during World War II and was repaired in 1955. The pavement has been repaired several times during its lifetime. The bridge is flooded frequently, often occurring annually or every few years since it is located in one of the most flood-prone regions in Croatia due to the specific karst topography and the behaviour of the Lika River. Despite its 12-meter height above the foundations, the bridge is regularly submerged. When the Lika River overflows, the bridge can disappear completely under water, cutting off the primary road link between two villages. Major flooding events, such as those in 2018 and 2022, have resulted in the bridge being fully submerged for several days (figure 6) [2].

Figure 6 Kosinj Bridge during high water levels of the River Lika

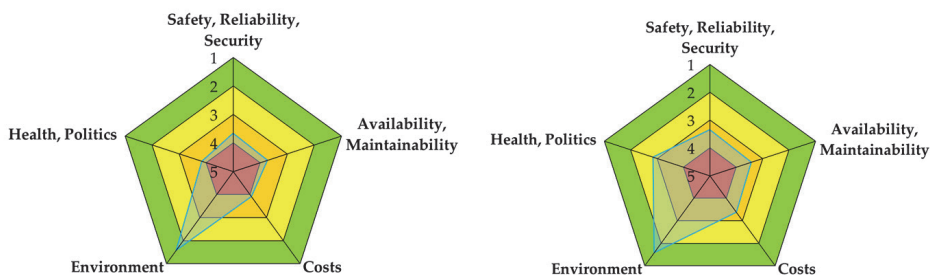
The condition assessment was carried out by evaluating four groups of structural elements (table 2): traffic surfaces and railings, abutment walls, arch intrados, and spandrel walls. Based on the visual inspection guidelines [3], it was concluded that the Kosinj Bridge currently shows no damage that would endanger local traffic of light passenger vehicles. However, without structural analysis it is difficult to accurately determine the remaining load-bearing capacity of the bridge. Additional investigations of the span structure are therefore required, particularly to assess the condition of the internal reinforced-concrete deck due to pronounced pavement cracking and heavy traffic loads. Significant cracks and calcification at the supports of the reinforced-concrete slab on the relief opening and arch crown indicate malfunctioning waterproofing, inadequate slab support, and overload for which the bridge was not originally designed. Numerous pavement cracks and surface irregularities may contribute to reinforcement corrosion due to water and de-icing salts and may also indicate discontinuities in the deck. Weather-exposed stone elements show typical deterioration such as black crust deposits and salt efflorescence, while many joints are overgrown or washed out; in some areas near the springing zones of the edge arches the joints are completely eroded, posing a potential risk of stone block detachment. The Kosinj Bridge should be preserved through a comprehensive conservation–restoration approach. First, diagnostic investigations should be carried out to determine the causes of deterioration, followed by appropriate non-destructive methods such as cleaning stone surfaces, desalination, consolidation of weakened stone, repointing joints, and local repairs. Regular monitoring and maintenance are also necessary to ensure the long-term stability of the bridge. The KPI assessment of the Kosinj Bridge was based on design documentation and the results of a visual inspection, evaluating indicators at the element and structural levels [4]. The analysis considered five KPIs (figure 7) with and without flood risk. The results show moderate to high concerns for safety, reliability and security, availability and maintenance, costs and health and politics (scores around 3.5–3.9), while Environment KPI is relatively low (1.58), indicating that maintenance, restoration, and flood-related risks are the most significant issues for the bridge. If the flood risk were excluded, the KPIs for safety, maintainability, costs and politics would be reduced by 10–25%, while environmental KPI would remain constant.

Figure 7 KPIs assessment for Kosinj Bridge with (left) and without (right) flood risk [2]
