THE EFFECT OF RAIL GRINDING AND RAIL CORRUGATION ON TRAMWAY TRACK NOISE AND VIBRATION LEVELS

Ivo Haladin, Dario Medvedić, Krešimir Burnać

University of Zagreb, Faculty of Civil Engineering, Croatia

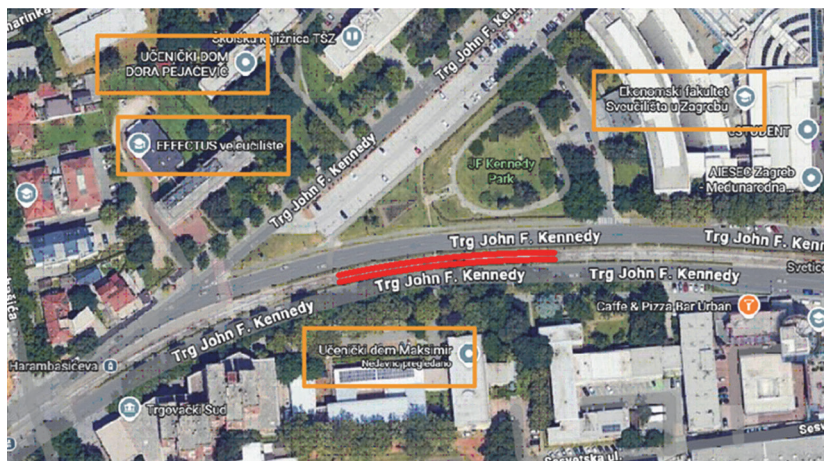
All of the on-site measurements were conducted the selected test section situated near John F. Kennedy Square, where rail corrugation had previously been visually observed on the running surface of the rails. The tram track at this section passes through a densely populated urban area with a high concentration of residential buildings, educational institutions, and student dormitories (figure 1); as a result, noise and vibration from tram traffic represent a significant environmental concern. These factors were taken into consideration when choosing this location. The measurements were performed in a horizontal curve with a radius of approximately 340 m, while neighbouring curves have radii of 285 m and 760 m.

Figure 1 Location of the corrugated test track section and grinded section with nearby buildings

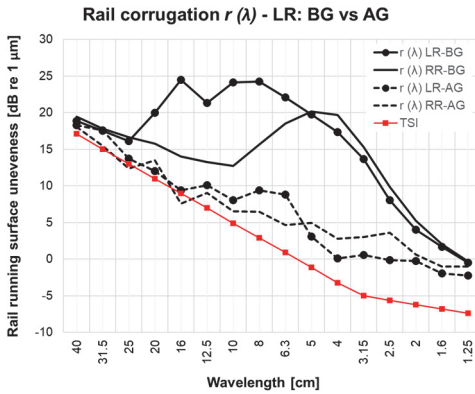
To analyze rail corrugation according to the HRN EN 13231-3 standard [8], longitudinal rail profile values were compared to the defined limits, both before and after grinding. Direct measurements ($n = 10$) of the longitudinal rail profile before grinding showed pronounced short-pitch corrugation, most significantly in the 10 to 30 mm and 30 to 100 mm wavelength ranges. Several averaged values for a 12.0 m measurement section exceeded the 5% limit set by the standard by a high margin ($> 60\%$) for 30 to 100 mm wavelength range, and $> 45\%$ for 100-300 mm range. Table 1 shows that grinding considerably improved the rail running surface condition by reducing corrugation and non-compliant measurement values.

It should be noted that the grinding process was performed more intensively on the right rail than on the left rail. Consequently, the remaining irregularities on the left rail may be partly attributed to the lower grinding intensity. With a more intensive grinding process, it is likely that the corrugation values on the left rail would also be reduced to fully acceptable levels. Graphical representations of the longitudinal rail profile according to the HRN EN 15610 [9] (figure 4) show that the grinding process successfully removed the periodic surface irregularities associated with corrugation. The results confirm that rail grinding effectively restored a smoother running surface of the rail head.

Figure 4 Rail corrugation on left and right rail before and after the grinding according to the HRN EN 15610 standard [g] in the wavelength domain

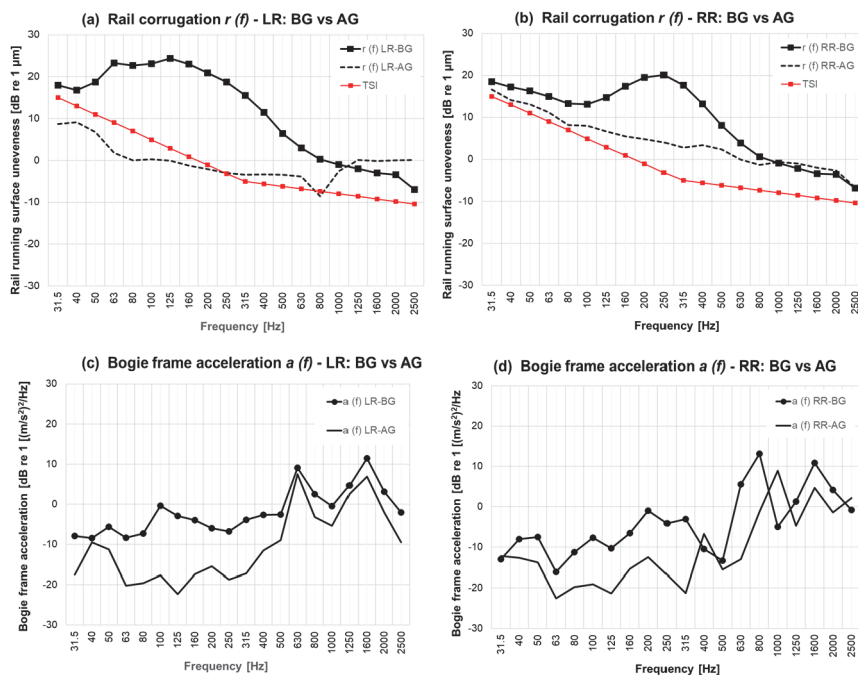
The analysis shown that when the tram vehicle travels at 40 km/h (figure 5b), the dominant rail corrugation wavelength of about 4 to 5 cm on the right rail before grinding (RR-BG; figure 4) generated vibrations in the frequency range of 200 to 315 Hz. The same comparison is shown for the left rail (LR-BG; figure 4), where the dominating wavelength prior to grinding is 16 cm, corresponding 63 Hz for the same operating speed (figure 5a).

Figure 5 Rail corrugation (a, b) and bogie frame acceleration levels (c, d) before and after the grinding presented in the third-octave frequency bands

The research revealed that the reduction in rail corrugation amplitudes was most noticeable at frequencies between 31.5 and 1000 Hz at both rails, with the highest reduction of values occurring at 125 Hz on the left rail and up to 15 dB at 250 Hz on the right rail. With respect to the rail corrugation amplitudes in figure 5a, b, the vehicle vibration data (bogie frame acceleration) showed the largest reduction of 18 dB at the left rail (125 Hz) and 15 dB at the right rail (315 Hz) in the 31.5 to 500 Hz frequency range (figure 5c, d).

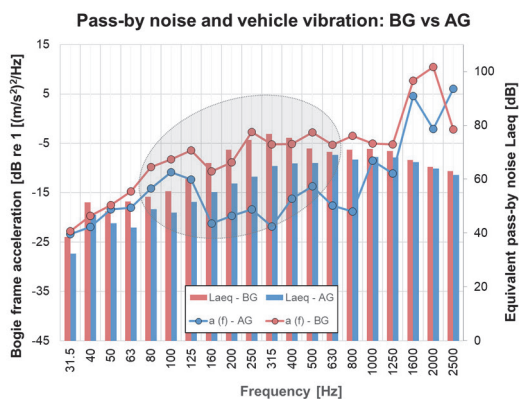
The presented comparison was additionally validated by the spectrum analysis of noise signals and vehicle vibration in figure 6. The analysis revealed that the rail grinding contribution to noise and vibration levels was most substantial in the 100 to 500 Hz range, with values reducing from 5 to 15 dB. After the rail grinding, pass-by noise levels decreased significantly, up to 15 dB at 250 Hz. This showed good agreement with the averaged vehicle vibration levels, as shown in figure 6. The left and right sides were averaged to provide a single value that took into account the contributions of both rails; and the most significant reduction of vibration levels was up to 15.5 dB also at 250 Hz.

Figure 6 Pass-by noise levels and vehicle vibration for a passage of tramway vehicle Končar TMK 2200 with $v = 40$ km/h, before and after the grinding
