Road and Rail Infrastructure III, Proceedings of the Conference CETRA 2014

SLOPE REMEDIATION METHODOLOGY ON THE ZAGREB-MACELJ HIGHWAY

Goran Grget¹, Katarina Ravnjak¹, Mladen Krpan²

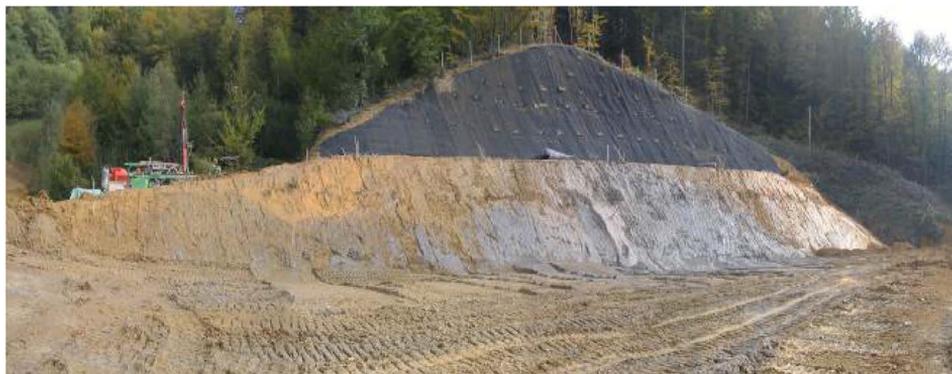
Gornji Macelj 4 slope location is built of mostly a fine-grained sandstone covered with a weathering rind, 1.0-5.0 m thick. An overlying crust consists of clayey sand with fragments of base rock material. Crust thickness is about 3.0 – 4.0 m. Figure 1 presents the slope during excavation. There is a visible boundary between the weathering rind and the sandstone bedrock. During the exploitation, the cracks in concrete revealed locations with the thicker weathering rind. Upper crust had displacement on the contact with the bedrock.

Figure 1 Gornji Macelj 4 cut during construction.

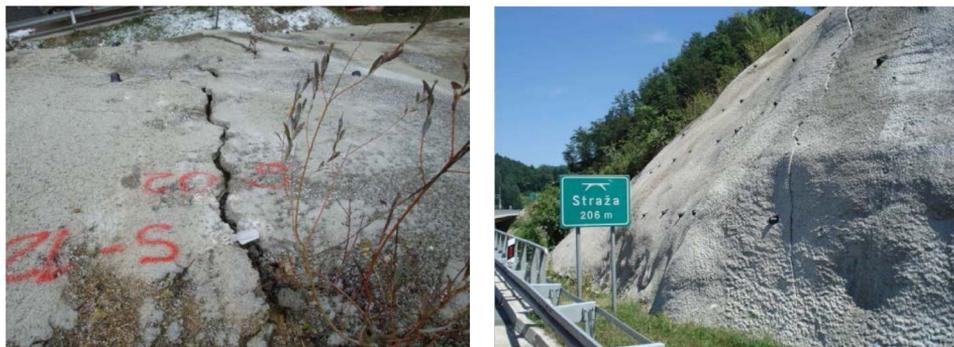
Main design has prescribed periodical monitoring of motorway by geotechnical designer and the motorway maintenance service. Design demanded monitoring during exploitation and to the inception reports. In the inception report defects were detected and quantified and also remediation measures were estimated with their priority order. Based on the report, the Investor ordered additional displacement measurement and detailed remediation design. On Straža Jug location during the visual observation the cracks in the shotcrete were detected on the northern part of the cut. It is peripheral part of the cut where slope changes inclination from 2:1 to 1:1.5. Crack was detected on the slope about 8.3 m from the beginning of the bridge. It was a vertical crack formed in the full height of the first slope floor. Crack width extended from 1.0 cm at slope toe to 5.0 cm at 10 m height. In period from autumn 2010 till spring 2011 crack displacement measurements were conducted. Measurements showed that crack was spreading and developing new cracks. This damage progression formed unstable blocks of shotcrete in size of a few square meters with potential risk for the motorway traffic. Defects were detected on the peripheral part of cut and eroded material from upper slope was deposited on the first bench. Also some material was carried out with water underneath of shotcrete in slope toe. Shotcrete has lost its slope protection function and was covering slope sliding like a mask. Monitoring results didn't find global stability problem, but local surface erosion and a problem of contact between slope and shotcrete was confirmed. At the end of

the winter period displacement progress decreased. Decision to start with the remediation measures was made because of the threat of shotcrete blocks to fall down on the motorway.

Figure 2 Defects and crack on Straža jug cut

At Straža jug cut first was removed cracked shotcrete and eroded material from the slope. In slope toe trench was excavated to the solid ground for the concrete foundation beam which supports renewed slope protection. Four rows of IBO anchors were installed at an angle of 15 ° from the horizontal and at 3.0x3.0 m grid. In upper two rows anchors with a length of 6.0 m and 3.0 m in a lower two rows were installed. The whole slope surface prepared for remediation was covered with 10 cm thick shotcrete reinforced with steel fabric mesh. Existing clogged perforated pipes were protected with geotextile during shotcreting.

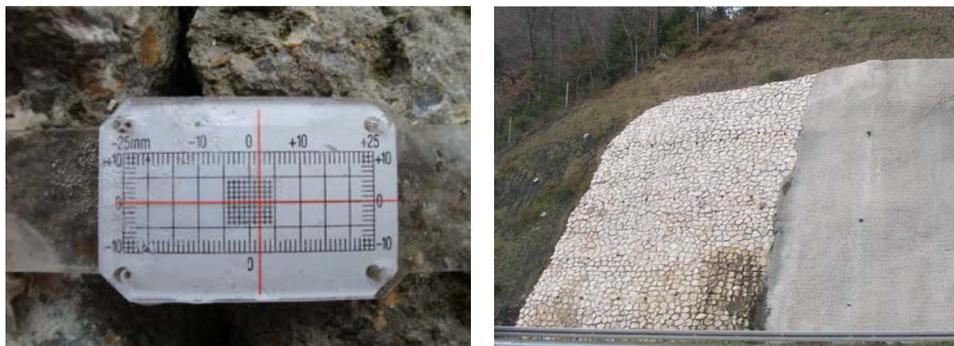
Visual observation at Gornji Macelj 4 cut detected crack on the contact of concrete stone wall and shotcrete. During 2010 crackmeters were installed and displacements on the cracks were measured. Crack was continuing from the lower slope to the first bench and extended parallel to the motorway (Figure 3). Crack width was from 1.0 cm at the bench to 10.0 cm at the slope toe. At the slope toe soil material was flushed out through the crack. It happened because the large amount of water was drained from the slope in this zone. Wet stain on the slope surface was visible and increasing (Figure 3).

Figure 3 Gornji Macelj 4 – installed crackmeter and vertical crack on the slope

Measurement and detailed visual observation determined that bench had 1.0 cm settlement on the side towards the motorway. Figure 3 shows installed crackmeter for measuring displacement on the crack at the contact of two types of slope protection. The crack was expanding and a measurement on installed crackmeters showed that slope with shotcrete protection was moving towards the motorway. This part of the slope had more than 5 mm displacement. Measured displacements and affected slope area indicated that defect was seriously impacting the road safety. The result of the monitoring was the decision to start slope remediation.

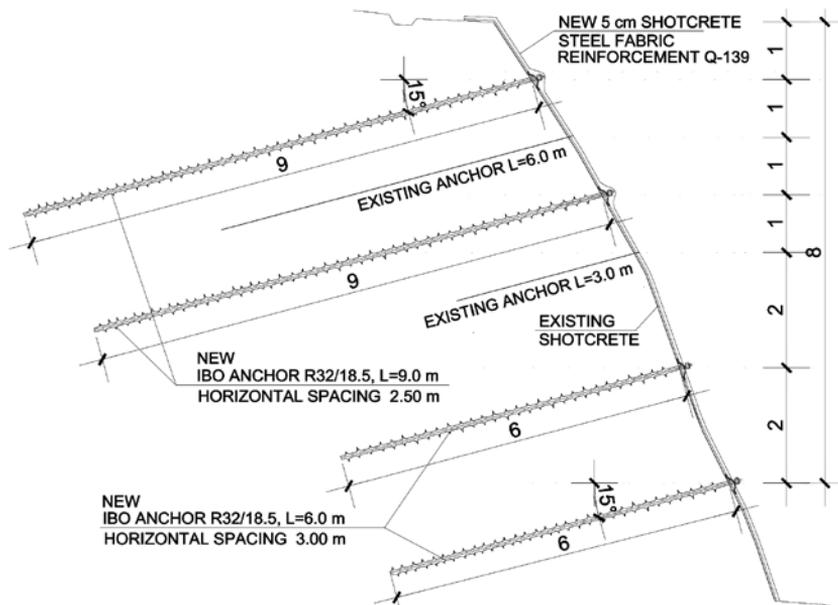
Figure 5 Typical cross-section of slope remediation at cut Gornji Macelj 4

At Gornji Macelj 4 cut remediation covered 5 m of stone concrete wall for overlapping and through all area underneath a horizontal crack on the top of the first slope floor. Figure 5 presents a typical cross-section of slope remediation. 4 new rows of IBO anchors were installed at an

angle of 15° from the horizontal and generally at grid 3.0×3.0 m. In upper two rows are installed anchor with a length of 9.0 m and 6.0 m in a lower two rows. The whole slope surface prepared for remediation was covered with 5 cm thick shotcrete reinforced with steel fabric mesh. Existing clogged perforated pipes were kept and protected during shotcreting and few extra were installed on places with detected water leaking.
