5th International Conference on Road and Rail Infrastructure
17–19 May 2018, Zadar, Croatia

Road and Rail Infrastructure V

SAFETY INSPECTIONS OF ROADS

Jan Petru, Vladislav Krivda

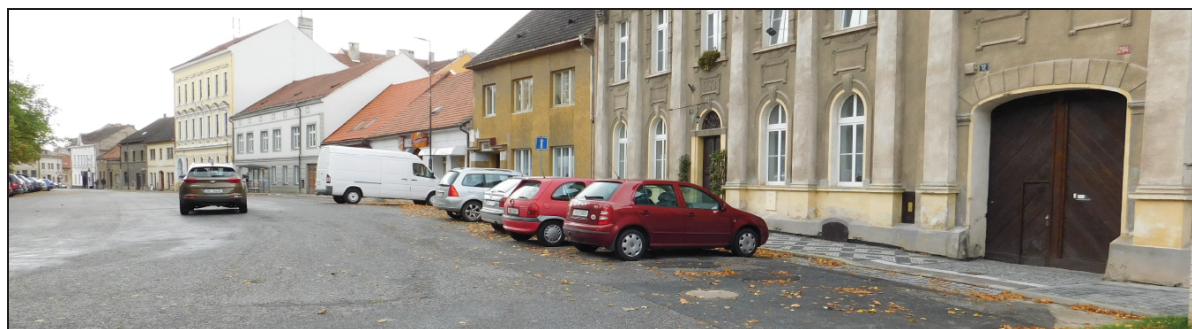
In particular, this includes failure in keeping the suitable width layout of the road [6]. Wrongly defined areas for dynamic and also static traffic, including the movement of pedestrians were recorder in the space (see Fig. 1). The road does not entirely meet the principle of self-explanatory road. The layout of the road, especially with local roads, encouraged speeding and, on contrary, was a barrier and risk for pedestrians and cyclists. At 50 % of localities there was static traffic in these areas (parallel, perpendicular or angle parking) and bus stops.

Figure 1 An example of a large traffic area – one-way road (the area allows any parking and it becomes a barrier for pedestrians)

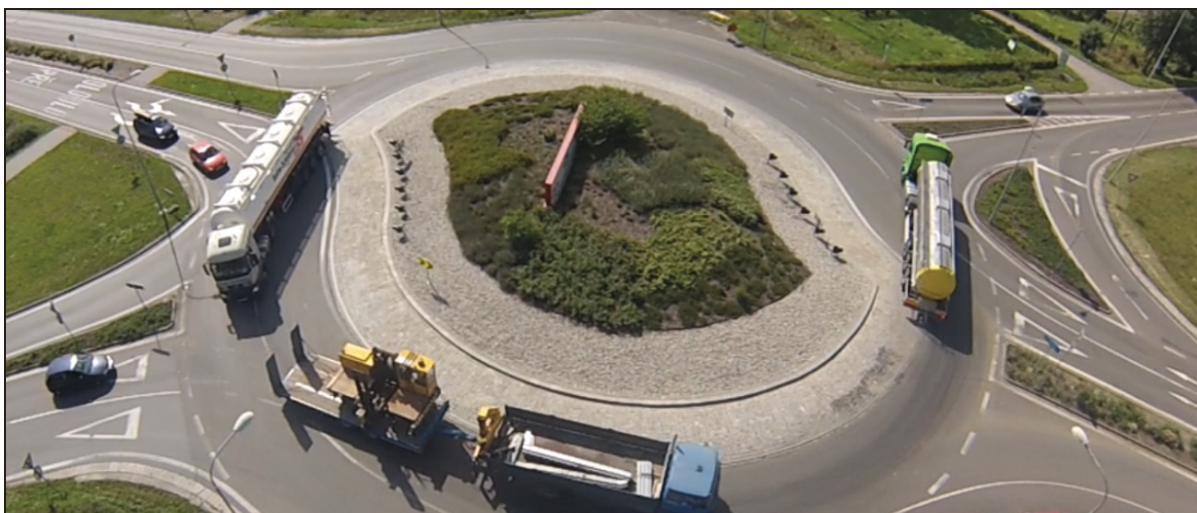
Figure 2 An example of observed conflict situation – passage of heavy lorry over two lanes (consequently other traffic participants are influenced). There is absent the physical separation of the lanes. Various serious situations were observed on this intersection. This intersection has an annual average of daily intensity of approx. 17 000 vehicle a day.

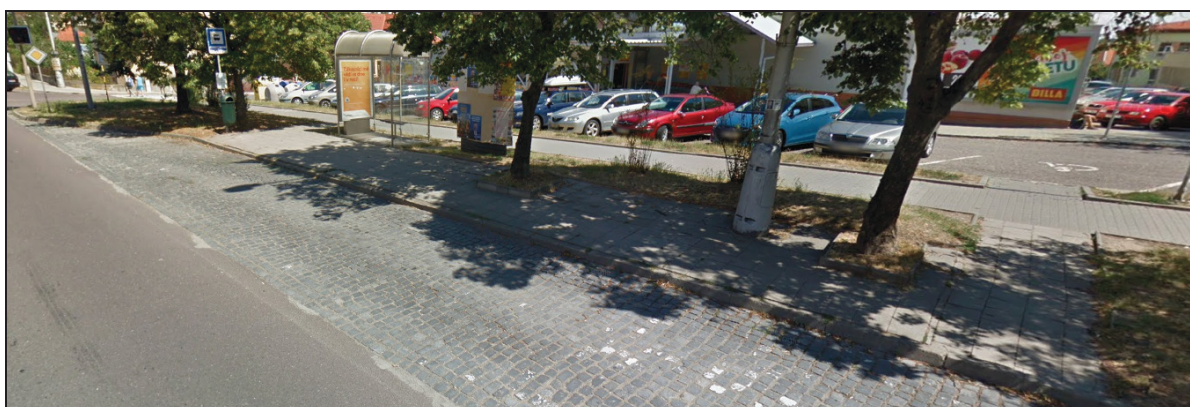
The risks that occur on bus stops were connected not only with the movement of pedestrians, but also with the movement of the public transport vehicles and with the movement of the traffic (see Fig. 3 and 4). The platforms of the stops were connected with risks of not securing contrasting signs of the entrance edge and the signs of the signal strip at the stop marker. The area of the platform did not meet the required width and there were fixed obstacles in this area. From the construction layout the bus stops did not meet the requirements on height of the entrance edge which is given by the standards and in many cases the surface of the road showed significant damages [8]. In 28 % of observed inspections there were exits on the entrance edge of the bus stop or there were situated pedestrian crossings. In smaller towns and villages the horizontal and vertical signs were missing.

Figure 3 An example of an inappropriate solution of the entrance area – the bus stop curb is missing and also the contrast signs of the entrance edge including the signal strip. In the area of the platform there are obstacles for the pedestrians. There is also a pedestrian crossing at the beginning of the entrance area.

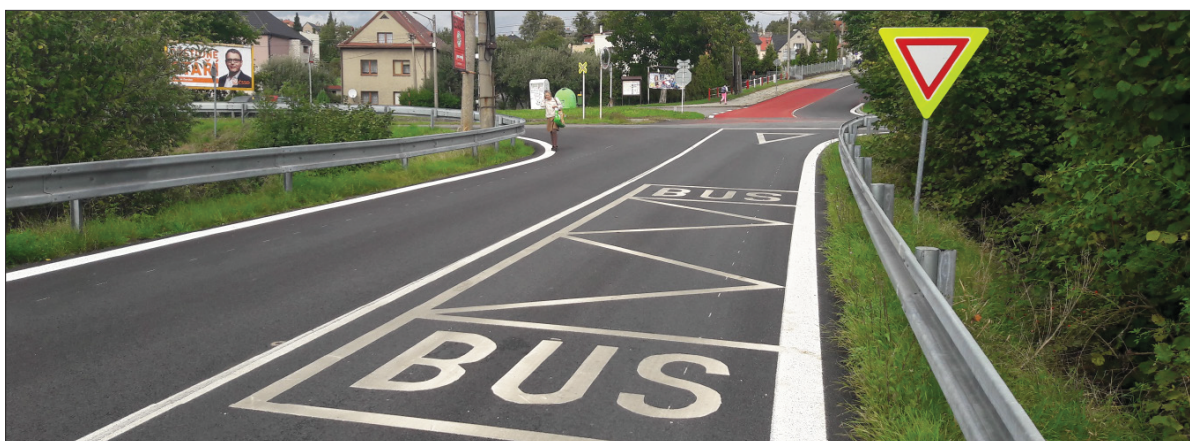
Figure 4 This part of the road was reconstructed, including the new traffic signs. In this locality approximately 20 connections stop every day. But the design of the bus stop area including the access for the pedestrian was not done. According to the information there is not a plan to do it in the future – high risk.

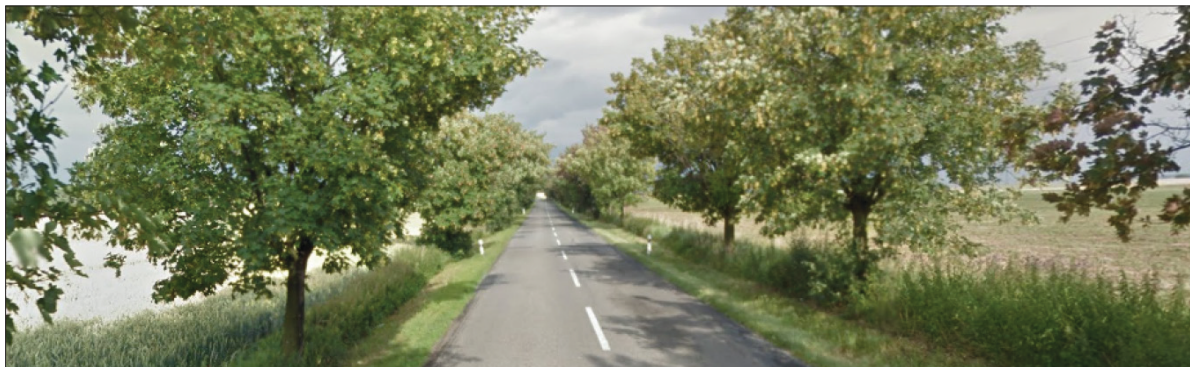
As a fixed obstacle we consider trees, bushes (with a diameter of branches $> 0,10$ m), columns, walls, columns of portal constructions, objects and elements protruding more than 0,2 m above the adjacent terrain, perpendicular walls of the culverts, etc. The risks were most frequently represented by trees (see Fig. C5), inclined parts of the culverts including outlet-headwall [4], poles (traction, lamps). At approx. 30 % of inspections were discovered the risks in connection to the nondeformable construction.

Figure 5 The fixed obstacle in the form of the roadside alley on the road of 2nd class with an annual average of the daily intensity of approx. 5 000 vehicles a day. The trees are very close to the road, in some parts they are in very bad conditions and there is a danger of falling of the trees on the road. In this area there were 65 accidents with fixed obstacle (tree) in last 6 years. Two of them had a loss of a life as a consequence.

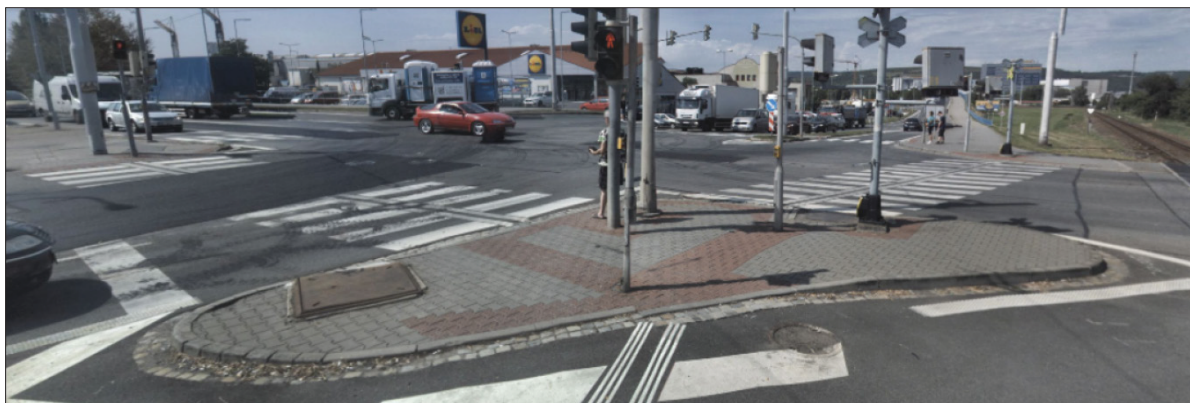
Moderate and in some cases also high risks resulting from non-compliance with the regulation about general technical requirements ensuring barrier-free access (Fig. 6) of constructions were found at 56 % of inspections. In total (low, moderate and high) safety risk was observed at 68 % of inspections. This involved improper usage of tactile strips (leading the person out of the pedestrian crossing or into the intersection, etc.). Further it was no signal when entering

Figure 6 The dividing island does not meet the requirements about general technical requests ensuring barrier-free usage of constructions. The tactile line does not follow the signal and warning parts. People are led outside the pedestrian crossing into a wide and busy intersection. Further there are many obstacles on the island (difficult orientation) including insufficient waiting area.
