5th International Conference on Road and Rail Infrastructure
17–19 May 2018, Zadar, Croatia

Road and Rail Infrastructure V

IN-SERVICE PERFORMANCE OF ROAD CONCRETE BRIDGES – SET UP OF CASE STUDIES FOR NOVEL PRO-ACTIVE MAINTENANCE METHODOLOGY

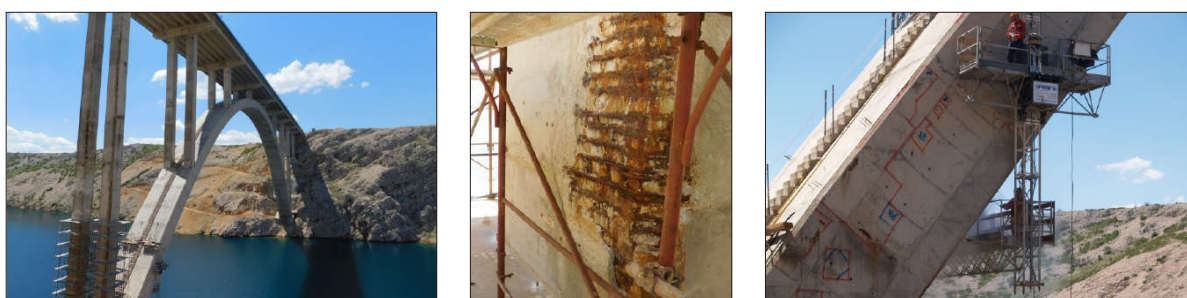
Figure 2 Repair of Maslenica Bridge after 20 years of service

reinforcing steel, testing concrete permeability (to gases, water absorption, chloride migration / diffusion). Those tests were determined as necessary for developing an appropriate repair design. It was concluded that the concrete compressive strength is approximately 20 % higher than prescribed in design specifications. Unfortunately, the testing related to concrete permeability showed poor results and the chloride content was above critical (0.4 % of cement mass) at approximately 20 % of concrete surfaces.

The repair has started in spring 2016 with 2 types of repair solutions employed depending on the results of corrosion risk assessment [14]. Structural members for which corrosion is

assessed to be still in its initiation period (arch, external main girders, all columns except those at the arch springing up to 35 m a.s.l.) are repaired by corrosion inhibiting impregnation, structural repair mortar and protective coating. Type 2 repair (for columns at the arch springing up to 35 m a.s.l. and arch abutments) includes repair with high strength micro reinforced concrete (with increase of concrete cover depth on columns), subsequently applying surface protection.
