VEHICLE MISMATCH – A CASE STUDY

Roman Mikulec, Pavlína Moravcová, Kateřina Bucsuházy, Martina Kostíková, Jakub Motl
Transport Research Centre, Brno, Czech Republic

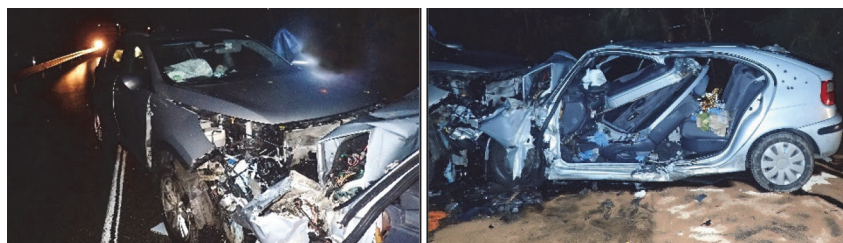
Figure 1 Incompatible collision, left: vehicle Kia; right: vehicle Renault.

- Front side of vehicle Kia was damaged, the deformation was extended up to the front axle of the vehicle. Both driver and passenger airbags were deployed.

- There was damage to the front part of vehicle Renault as well, however the deformation was of greater extent with engine mount damage and engine itself shifting inside the engine compartment. Vehicle passenger compartment was impacted as well. Dashboard was damaged and legroom was intruded, both driver and passenger airbags were deployed.

- Injury severity:
 - Driver of vehicle Kia (65 years old) sustained only minor injuries.
 - Driver of vehicle Renault (45 years old) sustained severe injuries – comminuted, open fracture of right femur lower part, comminuted fracture of lower end of right tibia, fracture of left femoral neck, sternum fracture, 9th to 10th thoracic vertebra fracture, fracture of 2nd to 4th metatarsus of left leg, overall injury severity expressed by ISS was 13. A passenger in front seat (43 years old) sustained minor injuries and passenger in rear right seat (37 years old) sustained severe injuries.

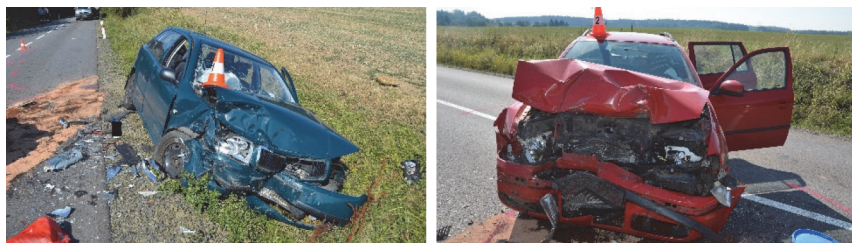
Figure 2 Compatible collision, left: vehicle Skoda Fabia; right: vehicle Skoda Octavia.

- Vehicle Skoda Fabia had damage of front right corner, the deformation was reaching right front wheel, which was shifted backwards, right front fender was destroyed, and right front rail was also damaged, the cross beam was shifted backwards. Both passenger and driver airbags were deployed.
- Front side of vehicle Skoda Octavia was damaged, the deformation was extended up to the cross bar. Both driver and passenger airbags were deployed.
- Injury severity:
- Driver of vehicle Skoda Fabia (84 years old) sustained only minor injuries.
- Driver of vehicle Skoda Octavia (37 years old) and two passengers (2 and 31 years old) sustained only minor injuries.

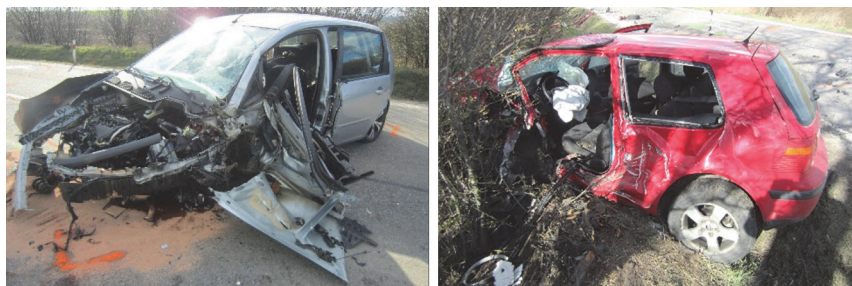
Figure 3 Incompatible collision, left: vehicle Ford; right: vehicle Volkswagen.

- Left and front side of vehicle Ford were damaged. The impact was pointed towards driver, which is the reason not only front side and engine compartment were damaged, but also A-pillar, left sill and left front door. Dashboard and driver seat mounting were damaged. Both driver and passenger front airbags were deployed.
- Left and front side of vehicle Volkswagen were damaged. In this case the impact was pointed towards driver as well, engine mount and left side were damaged. Leg room was intruded, and dashboard shifted inside the vehicle. Both driver and passenger front airbags were deployed.

- Injury severity:
- Driver of vehicle Ford (29 years old) sustained only minor injuries (chest bruises)
- Driver of vehicle Volkswagen (20 years old) was fatally injured. Front seat passenger sustained severe injuries.

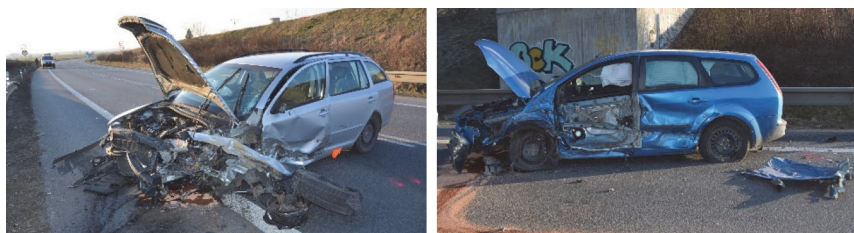
Figure 4 Compatible collision, left: vehicle Škoda; right: vehicle Ford.

- Front side of vehicle Škoda was damaged, the deformation was of mostly the left side of the vehicle and extended up to the front axle of the vehicle. The left front rail was not deformed, however left front wheel was ripped off and there was severe deformation of left A-pillar, left sill and left front door. Both driver and passenger airbags were deployed.

- Vehicle Ford had damage was focused to left corner, the deformation reached up to left front wheel, which was shifted backwards, left front fender was destroyed, left A-pillar was damaged and left door panel was ripped off. Left front rail was not damaged Only left curtain airbag was deployed.

- Injury severity:
- Driver of vehicle Skoda (32 years old) was not injured, a front seat passenger (35 years old) sustained only minor injuries.
- Driver of vehicle Ford (48 years old), front seat passenger (44 years old) and baby (2 years old), seated in the left rear seat sustained only minor injuries.
