## THE IMPACT OF WILDLIFE ON RAILWAY TRACK

Slavko Živković<sup>1</sup>, Ivan Barac<sup>1</sup>, Patricia Živković<sup>2</sup>, Ivan Pečina<sup>3</sup>, Bruno Brckan<sup>3</sup>

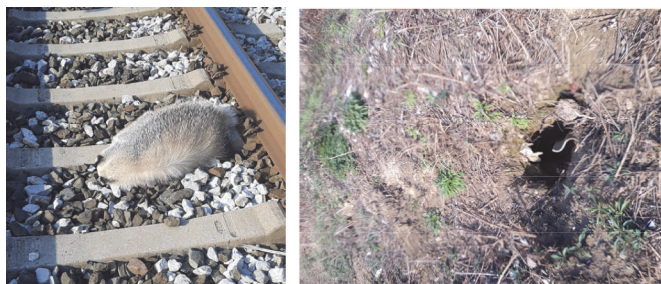
At the bottom of the embankment of the right (northern) track, a part of the railway line M104 Novska-Tovarnik-State border at 154+420/470 km, damage was observed (holes excavated by wild animals (badgers, foxes, etc.)). Approximately three m<sup>3</sup> of earth material was found next to the holes.

Figure 3 a) Badger on the track; b) Tunnel on the embankment

- On the subject line there was a weakening of the embankment caused by the wild animals;
- It is proposed to completely replace the embankment material on the right (northern) track as a permanent remediation measure;
- After the remediation, the slope is protected from wild animals with steel mesh.

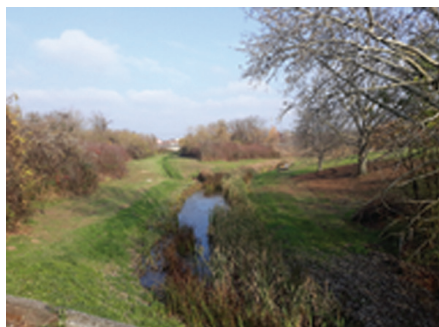
Figure 4 The watercourse of Ervenica

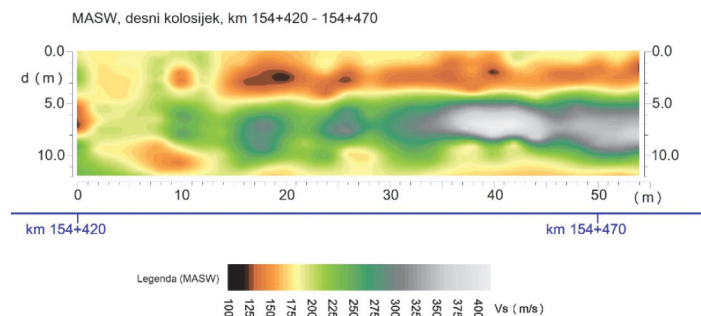
Figure 6 MASW method, right track, 154+200-154+470 km

From 154+420 to 154+433 km, velocities in the embankment vary 160-240 m/s. According to the speeds, it can be estimated that the embankment in this part, which is built of a mixture of gravel, sand and clay, is slightly more rigid than in the rest of the investigated area. From the section 154+433 km to its end, relatively low speeds were obtained in the embankment (<170 m/s). Therefore, these parts of the embankment have lower stiffness due to the dominance of clay in the structure. The lowest speeds have been registered at the 154+439 km and depth of 2.5 m. This can be directly related to the observed damage. Similar, but less pronounced can be said for the intervals of 154+446 and 154+460 km. From 154-429 km (the 9<sup>th</sup> m of the section) to the end of the research area at a depth of 4-9 m, the velocities are greater than 220 m/s. It is a layer of foundation soil built of solid clays. Deeper than 10 m in the foundation soil, there is a layer of lower speeds (150-200 m/s).

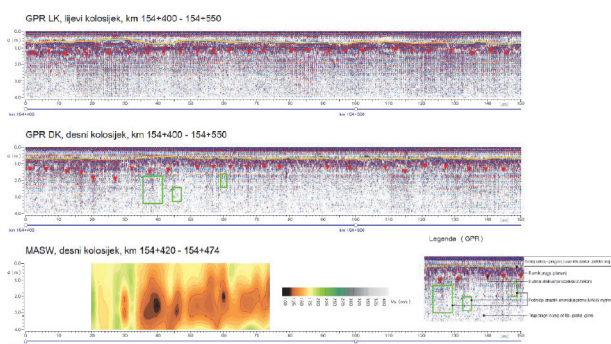
Figure 7 The GPR measures on the left and right track

The reflexes are weak in the area deeper than 1.2-1.4 m. It is difficult to single out the changes, because the embankment is made mainly of clay of relatively low resistance, high conductivity and strong attenuation of electromagnetic waves. The reasons for this can be the already mentioned signal attenuation and the nature of the damage. These are small channels, partially collapsed, with no significant changes in the electromagnetic characteristics of the material, which would lead to strong and noticeable reflexes. On the other hand, seismic MASW method distinguishes the changes in the dynamic characteristics of the embankment that can directly indicate the locations of damage.

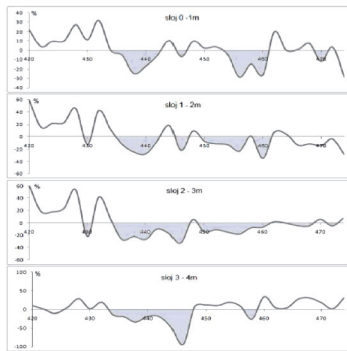
To estimate better the parts of the railway with the weakest characteristics, the calculation of the relative deviation (%) of the S wave velocities from the average velocities in depth interval 0-1, 1-2, 2-3 and 3-4 m (results in Figure 8; gray shaded areas indicate places where velocities are less than the average in the layer).

Figure 8 Anomalies – the weakest characteristics of the railway embankment

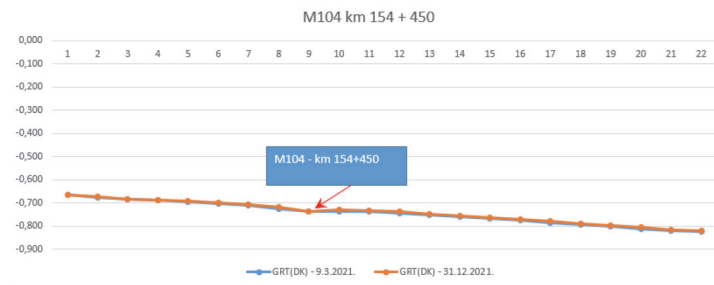
The graphic display of measured track level data for the part of the track 154+400-154+500 km is shown in Figure 10. At the area most often affected by animals, a subsidence is visible. The initial deformation of tracks did not change during the track level monitor time. The differences between the relative displacements obtained by successive measurements are negligible. According to the data based on the geometric usable condition of the track recording train Figures 11 and 12, the deformation longitudinal profile of the left rail is -10 is visible in km 154+448. There is also a distortion error in this parti in relation to the track in front of and behind this place.

Figure 10 Track level diagram, right track, 9.3.2021.-31.12.2021

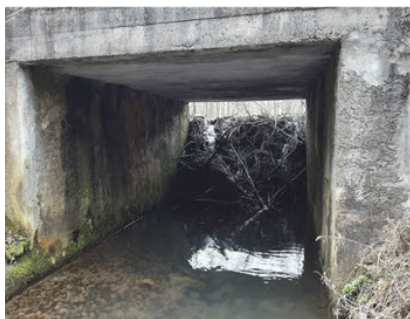
In addition to the processed action, we will give some one more examples with possible consequences. The aim is to point out the possible consequences of the joint action of climate change and animals. Beavers close the gaps of water duct by creating habitats for life. With the sudden flow of water through the water duct (Figure 14), vortexing occurs on the other side and craters form. Figure 15 shows a crater caused by clogged water duct during a major flood due to the overflow of the Sava River.

Figure 14 Water duct buried

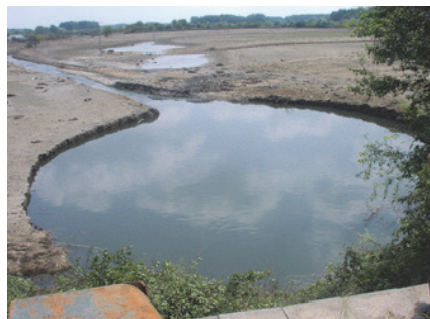
Figure 15 Damage caused by floods
