SCANNING AND THERMOGRAPHIC SURVEYING FOR NEEDS OF ELABORATION OF PROJECT FOR RAILWAY TUNNELS REHABILITATION

For the needs of elaboration of the project for rehabilitation of Košanski, Križiški, Jurgovski and Ležeški railway tunnels on the section of the railway between the Košana and Gornje Ležeče stations, scanning and thermographic surveying of the secondary tunnel lining was carried out. The mentioned field measurements were carried out by the SPECETES TS3 tunnel scanner which operates with a rotating laser beam and a visual field of 360 degree. Coordinates of permanent points in the tunnels set for the needs of measuring were also measured and calculated. The complete surveying equipment was installed on a railway car, which was pushed by a rail vehicle during measuring at the speed of 2 km/h. Surveying was followed by data processing and elaboration of a mathematic model of the tunnel tube, which enabled selection of the optimum position of the track route in the tunnel. From the data obtained by thermographic surveying, places with a smaller and larger quantity of seepage water were located.

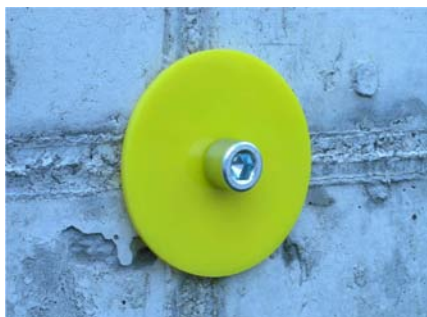
Figure 2 Permanent point

Before measurement itself, on the subject railway section, the training grounds were stabilized, measured and calculated, from which coordinates of permanent points in the tunnel were determined. Permanent points were stabilized in all the tunnels for the needs of directional and height securing of the tracks, and for the purpose of placing the results of detailed measurements with the laser scanner into space. Their stabilization was executed by screws attached into the secondary lining of the tunnel on yellow plastic washers with the diameter of 7cm, alternately on the left and right side of the tunnel, in cross-sections where the contact network consoles are situated (Figure 2).

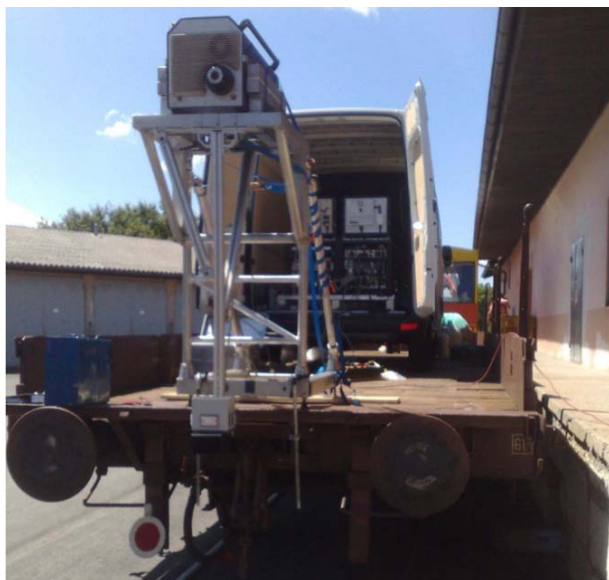
Figure 3 Complete equipment with van on railway car

For surveying needs, it was necessary to attach firmly (fix) the scanner support on a railway car. The correct position of the scanner on the railway car is the basis for surveying accuracy. Complete setting, testing of the scanner and computer equipment, and placing of a van on a railway car was done a day before surveying (Figure 3). Surveying itself was carried out during one track closing, by pushing of the railway car by a motor driven rail vehicle, which moved at the speed of 2km/h to ensure the best possible measuring accuracy.

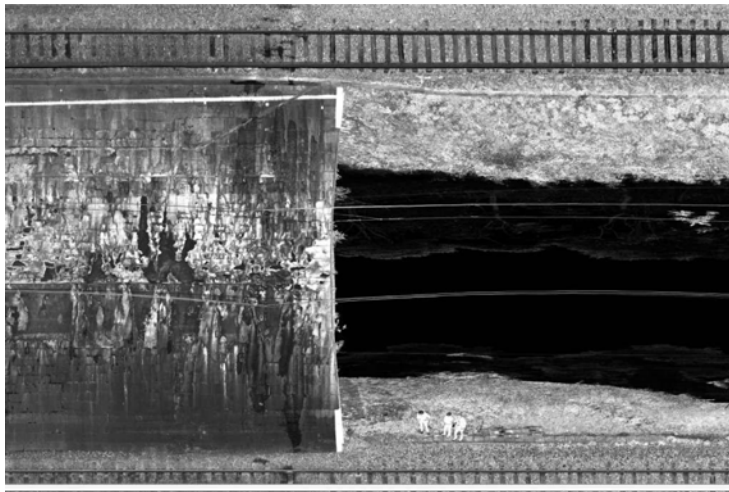
Figure 4 Scannogram, partially in tunnel, and partially outside tunnel

Since a double-track railway was in question, for which the most accurate data possible were to be obtained, surveying was performed twice, specifically, once along the left-hand, and once along the right-hand track. The scanner by which measuring was done operates with a circular laser beam in the 360 degree visual field, and it enables measuring of tunnel cross-sections, a visual recording of the tunnel lining and a surface thermographic recording of the tunnel, which is of importance to us for locating water behind the tunnel lining (Figures 4 and 5). The distance between individual cross-sections is several millimeters, the scanning resolution is up to 10.000 pixels on 360 degrees per a cross-section [2].

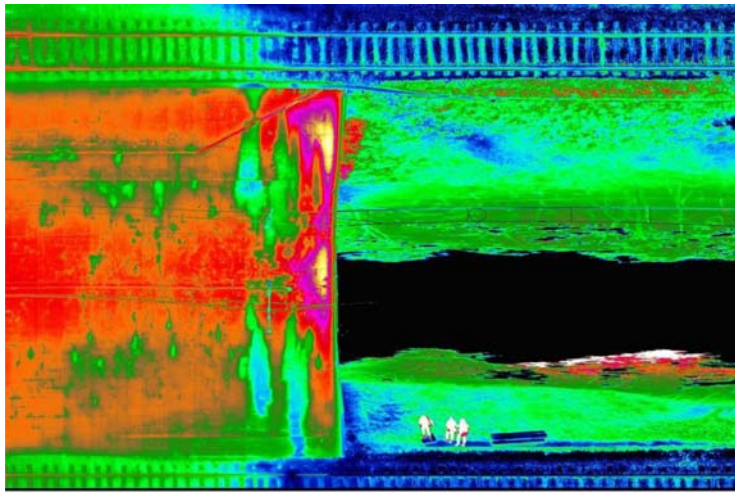
Figure 5 Thermographic survey, partially in tunnel, and partially outside tunnel

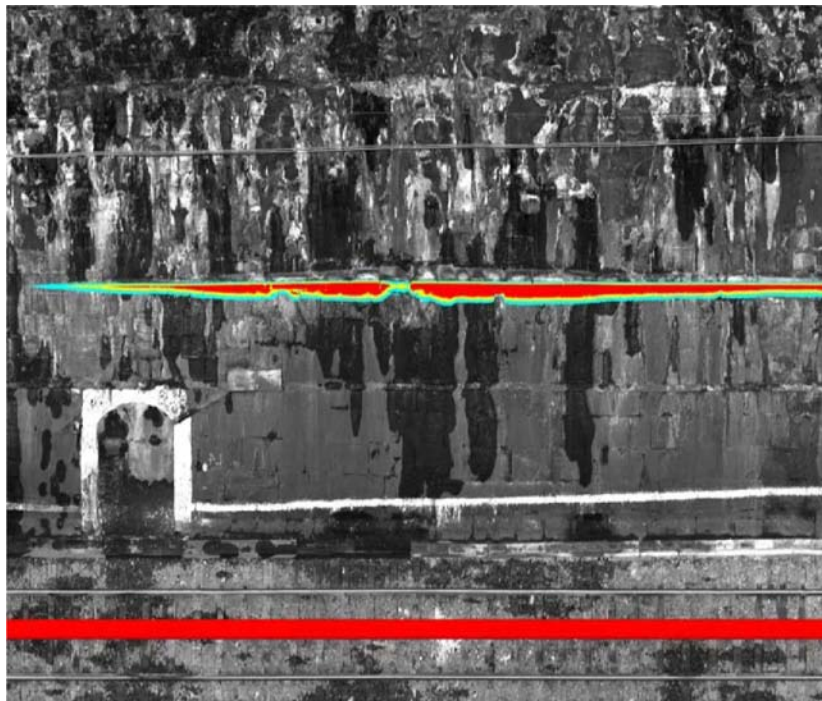
Figure 6 Scannogram with marked places of intervention of selected cross-section into tunnel lining

By that program, a mathematical model of the tunnel tube was elaborated, which enabled us to select and show the cross-section at any chainage. Such a procedure ensured quick control of variant solutions during optimization of the track route in the tunnel. In this actual case, the following was obtained: the distance of the track axes was increased and the curve elements were improved, which resulted in an increase of speed, and all that, with minimum interventions on the tunnel lining. After selection of the optimum position of the track in the

tunnel tube, control of cross-sections was done, and conflict points were located (Figure 6 and 7, [1]). From the data obtained by thermographic surveying, places with a smaller or larger quantity of water behind the tunnel lining were located. That data was used during determining the quantity and type of grouting mixture that will be embedded (injected) behind the tunnel lining for the purpose of preventing penetration of water per a tunnel lining.

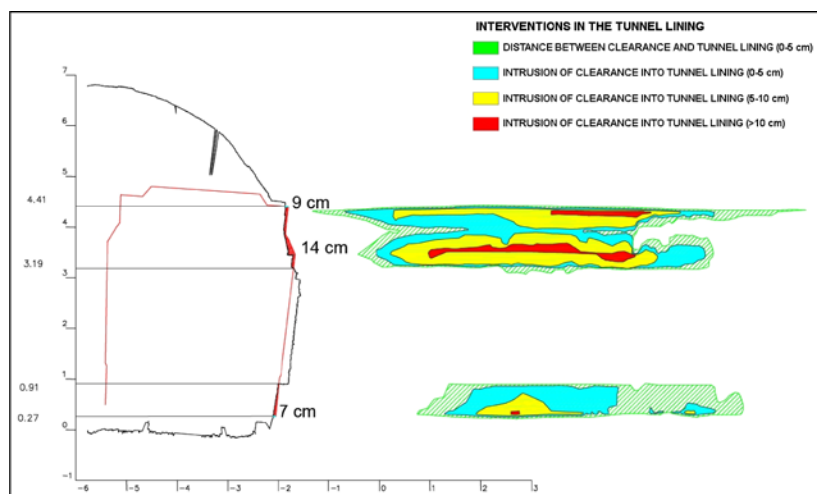
Figure 7 Size of intervention in tunnel lining
