## CATHODIC PROTECTION OF PELJEŠAC BRIDGE REINFORCEMENT – IN-DEPTH ANALYSIS OF THE SYSTEM

Krešimir Kekez<sup>1</sup>, Tea Antolović<sup>2</sup>, Dražen Pažameta<sup>1</sup>, Goran Pavliša<sup>1</sup>

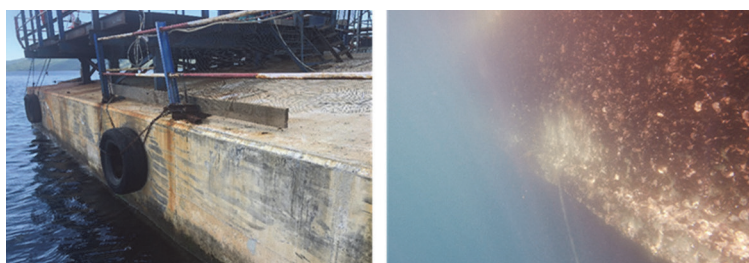
Figure 3 Pile caps above and below the water line

Pile cap is steel reinforced concrete element that gathers the piles. It is massive in dimensions; 23.00 m x 29.0 m x 5.0 m 2.5 m and accommodated in the splash zone 2.5 m above and 2.5 m below the water line, hence exposed directly to the chloride ions, Figure 8 and 9 [3].

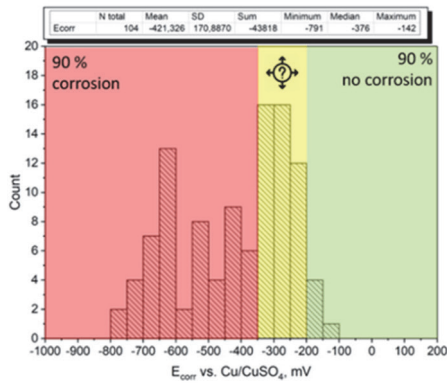
Figure 6 Distribution of corrosion potential values over randomly chosen concrete surface

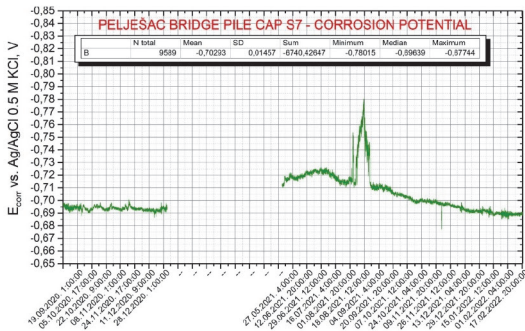
Figure 7 Corrosion potential long-term logging at randomly chosen permanent reference electrode in concrete

Long term monitoring of corrosion potential on randomly chosen embedded reference electrode shows stability and no major fluctuations, figure 7. Explanation goes in a favour of stable conductivity of the concrete, respectively of no major changes in moisture.

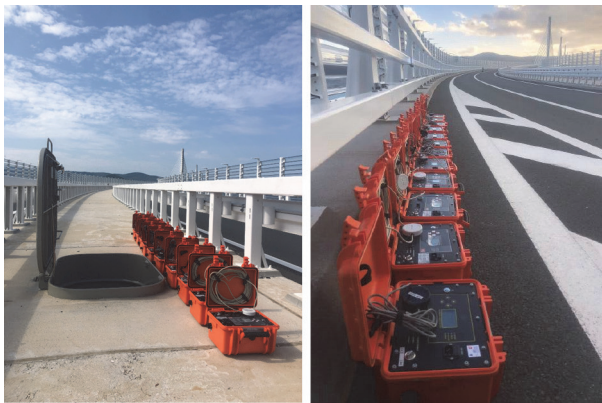
Figure 14 Synchronised current interrupters used to simultaneously interrupt all 20 CP units
