Road and Rail Infrastructure IV, Proceedings of the Conference CETRA 2016

CONCRETE MIX DESIGN FOR THE REMEDY OF CORRODED CONCRETE SLEEPERS

Fitim Shala, Muhammad Umair Shaukat

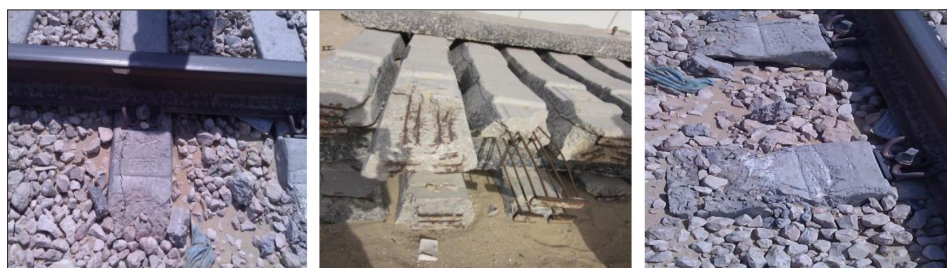
- Quite a few concrete sleepers are marked by fresh open longitudinal cracks which are clearly not associated with the action of any external environmental corrosive factors but are obviously generated by mechanical fatigue and oversteering.

- Concrete sleepers aggressed by corrosion with cracks and spalled off concrete chunks with visible corrosion trace marks of the reinforcement bars presumably by chloride penetration. No visible marks of sulphate attack were seen on the concrete spalls. The most likely source of chlorides it is surmised to be the uprising moisture due to capillary phenomena of a shallow salivated ground water table as it can be concluded from field observations of the broader area. Yet the windblown sand which is in direct contact with the track elements may not be excluded as a possible source of chlorides but this only can be safely indicated by the soil analyses of chemical and mineralogical composition.

Figure 1 Cracked and Corroded Concrete Sleepers (km 19, 25, 31 & 37)

- Concrete damage started at the sides of the sleepers and propagated towards the centre (see fig. 1).
- Sever corrosion is recorded on the anchor plate and nearby rebar's (see fig. 2).

The anchor bolts holes although filled with non-shrinkable grout, provide access to carbon dioxide, Chloride, Humidity and Oxygen. Carbon dioxide and Chlorides will decrease the pH of the concrete porous solution. At decrease pH, rebar's will lose their passivity (Iron oxide film which is stable at pH of +12 will break down at lower pH and expose metal underneath to corrode). This reinforcement corrosion process would result in corrosion products that occupy greater space than the original steel and will apply stress on the concrete causing it to crack and provide further access to salts, carbon dioxide, oxygen and humidity which accelerate the corrosion process. Eventually concrete will spall and integrity will be lost (see table 5).

It is indicative that the deterioration of the concrete of the sleepers is due to electrochemical corrosion of the steel reinforcement. As per the FHWA, when the rebar corrosion is electroche-

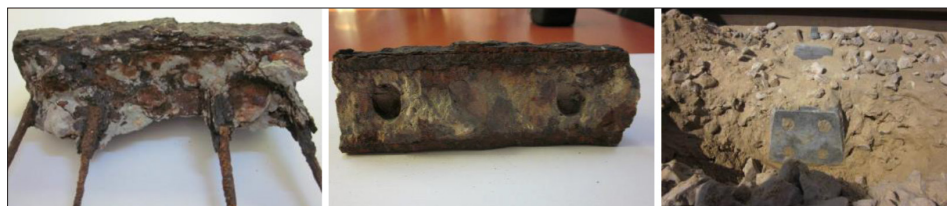
- Filling material (non-shrinkable grout) for the bolts anchor holes was easy to chip.
- The soil around the sleepers was damp (see fig. 2)

**Figure 2** Severe corrosion on anchor plate & rebar, on anchor plate
