4th International Conference on Road and Rail Infrastructure
23-25 May 2016, Šibenik, Croatia

RECONSTRUCTION OF THE RAILWAY TUNNELS TIČEVO, KLOŠTAR AND RESNJAK

The reconstruction of the railway tunnels Tičevo, Kloštar and Resnjak was carried out as a part of the reconstruction and modernization of the RH2 corridor railway line M202 Zagreb Main Railway Station – Rijeka. Reconstruction of the railway tunnels Tičevo, Kloštar and Resnjak, each of which is characteristic in its own right, entailed the reconstruction of the tunnels, tunnel portals, approach cuttings at the tunnel entrance and exit, by installation of the state-of-the-art materials, using the specific technology of execution of works, and respecting the defined railway line closures to ensure railway transport safety, and reconstruction of the civil-engineering, power-electric, control-command and signaling and interlocking subsystems as a single unit.

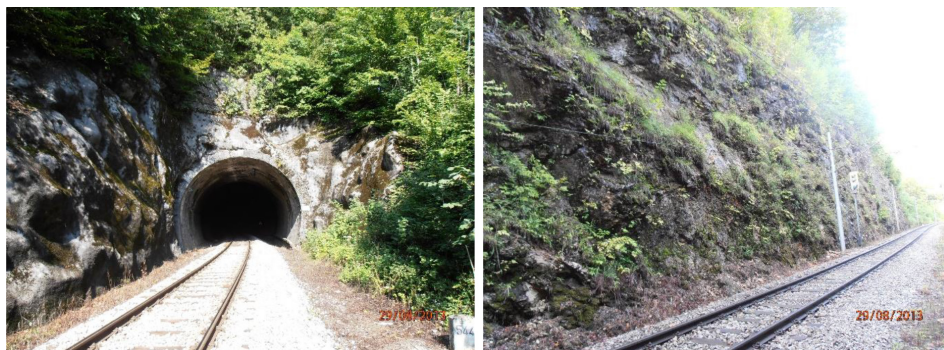
In selection of the solution of reconstruction it was necessary to take into consideration the height of the overhead line equipment and its minimum distance from the tunnel vault, meeting of conditions of the GB structure gauge, and in the approach and exit cuttings, for the sake of integration into the natural surroundings and preservation of the original configuration, the technical solution should be such to let it blend into the natural surrounding and retain its authentic configuration and appearance, and at the same time to be in line with the technology of works on the railway lines (carrying out of works at a fast pace within a short period). All railway tunnels are constructed without hydro-insulation which protects from penetration of water, and the rings of dressed stones are at the same time their primary and secondary lining. Tunnel Tičevo, 173 m long, was constructed in 1872 for two tracks. It is situated between the stations Ogulinski Hreljin and Gomirje and consists of 19 tunnel liners, rings of dressed stones with the interspace of the live rock, and the overburden of ca. 10 m, on which here and there is shotcrete. The entrance portal has already been reconstructed with shotcrete and exit portals are situated in the live rock. The approach cutting and exit cutting are also in the live rock.

Figure 1 Entrance portal of tunnel Tičevo and the exit cutting

In tunnel Tičevo reconstruction works are divided into three groups: reconstruction of the unstable zones of the stone lining, reconstruction of the unstable zones of the stone lining and reconstruction of the rock mass. The reconstruction of the unstable zones of the stone lining comprised the stretches in the tunnel vault of the stone blocks “wedged” by the small wooden wedges which protected the stone blocks from the loss of stability, and the reconstruction of the site where stone blocks started protruding towards the tunnel gauge. After the machine and manual removal of the shotcrete from the surfaces where it was placed, the surface was washed and cleaned. Since the dressed stones in the vault visually pointed to the questionable stability, the next step was installation of the steel fabric and application of the sprayed mortar, so that the outlines of the steel fabric were visible, and that the dressed stones could bind and harden. The contact and binding injection was followed by the drilling of the holes and installation of the adhesion bar anchors, their injection, fastening and application of the 5 cm thick sprayed mortar. Into the tunnel flanks at the top of the tunnel wall, the soakways were installed, and where it proved necessary to channel the line in order to reduce the seeping of water and pressure on the tunnel lining, the number of the installed soakways was increased. The last phase was application of the permanent elastic poly-cement coating in three layers which, due to rugged base, was applied without net. The caverns in the tunnel were reconstructed by the steel fabric and sprayed mortar. The zones of the entrance and exit portals were protected by the steel fabric, sprayed mortar and soakways.

The cutting approach and exit of the tunnel were reconstructed by manual and machine removal of the unstable stone blocks. The stability of the cutting approaches and exits was provided by the system of the hexagonal, double-twisted protection nets Pr 400/550 MPa by the fixed bar anchors, system of the bar anchors and protective pre-stressed retaining net type TECCO of high tensile strength of 1770 N/mm². On both sides of the cutting approach and exit, in the entire length because to the cable of the signalling and interlocking electric power infrastructure subsystem, and the proximity of the foundation of the contact wire and the cutting exit, instead of the concrete channels type II, the drainage pipes are installed.

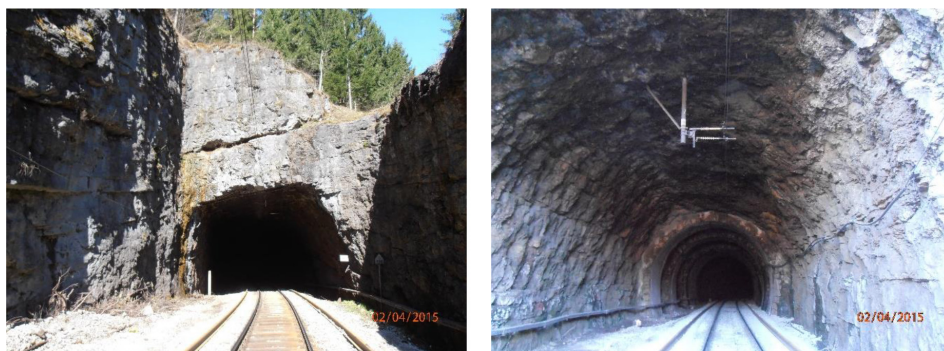
Tunnel Kloštar, 248,40 m long is situated between stations Gomirje – Vrbovsko. It was constructed in 1872 in the limestone rock with the overburden of ca. 7 m. It has five tunnel liners, i.e. rings of dressed stones with the interspace of the non-lined rock. Its width accommodates two tracks. On all five rings there is shotcrete of questionable stability. The entry and exit portals are of the live rock above which there is the earth mass underpinned by the mass of the trees. The approach and exit cutting are in the live rock.

Figure 2 Entrance portal of tunnel Kloštar and tunnel's interior

Reconstruction of tunnel Kloštar was carried out in two ways: by reconstruction of the rings of the dressed stones and reconstruction of the rock mass. From the dressed stones first the old shotcrete was removed manually and by hydro-demolition. When the works began, one part of the shotcrete fell off by itself. After removal of shotcrete, the washing was carried out, as well as the contact and binding injection along the entire length of the ring from the foot to the crown. At the frontlines of the rings the steel fabric and sprayed mortar were installed, and as the final phase, the permanent elastic coating in three layers, with the net, was applied. After cleaning and washing, in the rock mass the micro-cracks were detected, from which the seeping of water onto the track was visible. In line with the project supervision, due to large-scale roughness in the tunnel vault, instead of sprayed mortar, the sprayed concrete with fibres was installed, so that the steel fabric could be installed, to be protected by the sprayed mortar in the following phase. Water which was seeping from the vault was channeled by the small pipes before installation of the steel fabric into the flanks of the tunnel by the rock wall. The permanent elastic coating in three layers without net was the last phase of the works on the rock. During execution of works, after injection of the second ring, in the period of heavy rainfalls, through the soakways of the second ring, a large quantity of water seeped along the front of the track wooden sleepers, so the channels which were installed to channel the water towards the channels in the cutting approach. The entrance and exit portals were protected by the protective pre-stressed net type TECCO G65/3 of high tensile hardness of 1770 N/mm² and by the system of the bar and cable anchors. The caverns at the entrance and exit portal where reconstructed by channeling the water through the drainage into the corners of the portals outside the structure gauge zone, and the cracks were filled by the sprayed concrete.

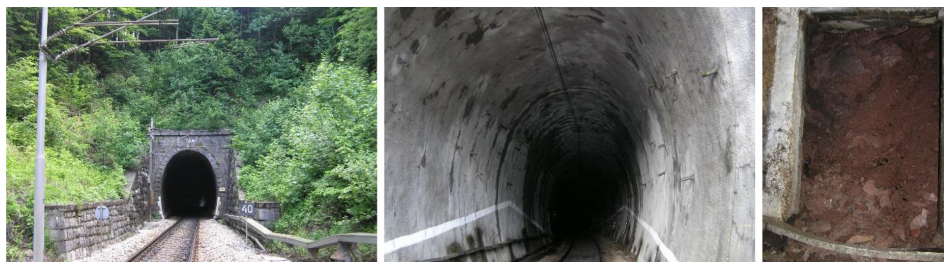
Tunnel Resnjak, 197,72 m long, is situated between the stations Zalesina and Delnice. The tunnel was constructed in 1873 for one track of the GB structure gauge (basic). It consists of seven niches which are situated at every 25 m. It is clad with the dressed stones in 34 tunnel liners, and here and there, there is shotcrete. The entrance portals, frontal walls and the wing walls in the approach cutting and exit cutting are also made of dressed stones, above which there is very unstable soil with tendency of sliding and rockslides. From the last niche before the exit portal, the material has been falling onto the track; therefore for safety reasons the slow running of trains of 20 km/h is introduced in the tunnel.

Figure 3 Entrance portal of the tunnel Resnjak, interior of the tunnel and the niche from which the material is falling

Reconstruction of the tunnel Resnjak due to the critical structure gauge also differed in the reconstruction of the last niche before the exit portal from which the material was uncontrollably slipping onto the track. The first activity in execution of the reconstruction works was to identify places where the shotcrete of weak adhesion capacity, deteriorated and broken, and to remove it. In order to carry this out, the entire tunnel was “knocked” mechanically by the hammer (the adhesion capacity was checked by the hammer, and the sound provided the information of the adhesion of the shotcrete onto the base). Removal of the shotcrete was carried out in some places, manually and with machines along the entire tunnel. Those places for which it was found to have good adhesion, the pull-off method was made, which confirmed it. After washing and cleaning, the holes for the bar anchors were drilled into the broken parts of the stone blocks, the anchors were installed and injected. Sporadic injecting was carried out in the tunnel vault, and binding injection in the tunnel wall, followed by installation of the steel fabric and 3 cm thick sprayed mortar. During works of shotcrete removal in the tunnel vault, several yellow plastic half-pipes were found, which were channeling water into the flanks, and they were situated under the shotcrete. Since during the summer time period a large quantity of water was seeping onto the track, twelve half-pipes were installed in the tunnel, some of which were visible, and some where protected by the sprayed mortar, since the structure gauge allowed that. The last phase of works was application of the permanent elastic coating. Reconstruction of the last niche before the exit portal of the tunnel entailed the removal of the unbound parts of the rock mass, construction of the reinforced concrete pillow with the armature, drilling of the anchors and injecting above the niche vault. In the niche the soakways were drilled, the niche was clad and protected by the sprayed mortar and permanent coating. All other niches in the tunnel were reconstructed by washing, cleaning, underpinned and protected by the sprayed mortar and permanent elastic coating. After completion of works, the marks of the niches in the tunnel were outlined too.

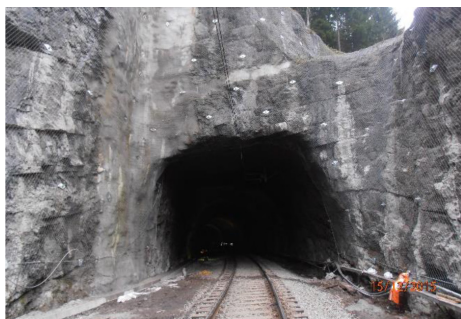
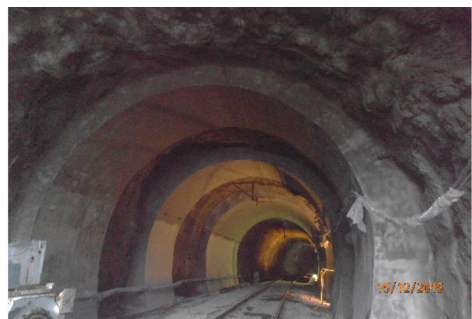
Figure 5 Cutting approach and entrance portal of the tunnel Kloštar and the rings at the exit part of the tunnel after reconstruction

Reconstruction of the cutting approaches and exits was carried out by the manual and machine cleaning of the slopes, installation of the pre-stressed protection net DELTAX of

high tensile hardness of 1770 N/mm^2 which was fixed by the system of anchors. On the left side of the cutting approach and exit, the channels type II were installed, which channel the accumulated water.

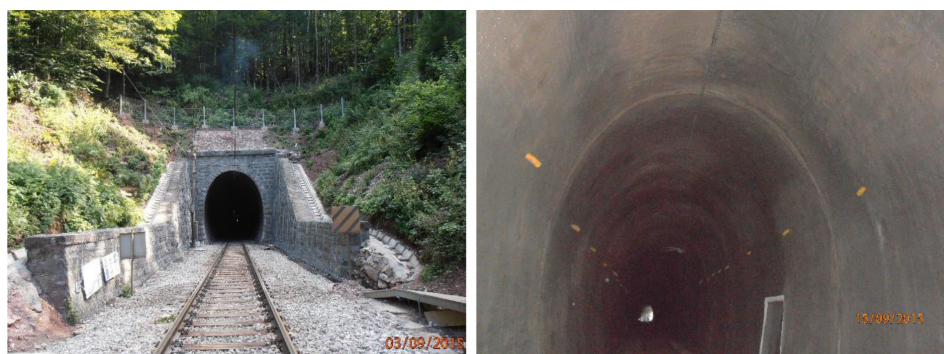
Figure 6 Cutting exit of tunnel Resnjak and interior of the tunnel after reconstruction

Reconstruction of the cutting approaches and exit cuttings of the tunnel was carried out by construction of the anchors, hexagonal double-twisted net of the cords and before their installations the drains were drilled and the dressed stones were bound by injection including the leveling of the grooves. Above the entrance and exit portal the barrier of posts, net and steel cords was constructed. The posts are constructed of the steel profiles NPI-20 and NPI-16, anchored into the concrete foundations at the distance of 3 m. The net of the barrier is hexagonal, double-twisted and galvanized. On the left and right side of the cutting exit and above the entrance portal, the concrete channels with descent were installed.
