Proceedings of the
5th International Conference on Road and Rail Infrastructures – CETRA 2018
17–19 May 2018, Zadar, Croatia

THE COMPREHENSIVE ANALYSIS OF A HIGH RISK SITE: A CASE STUDY

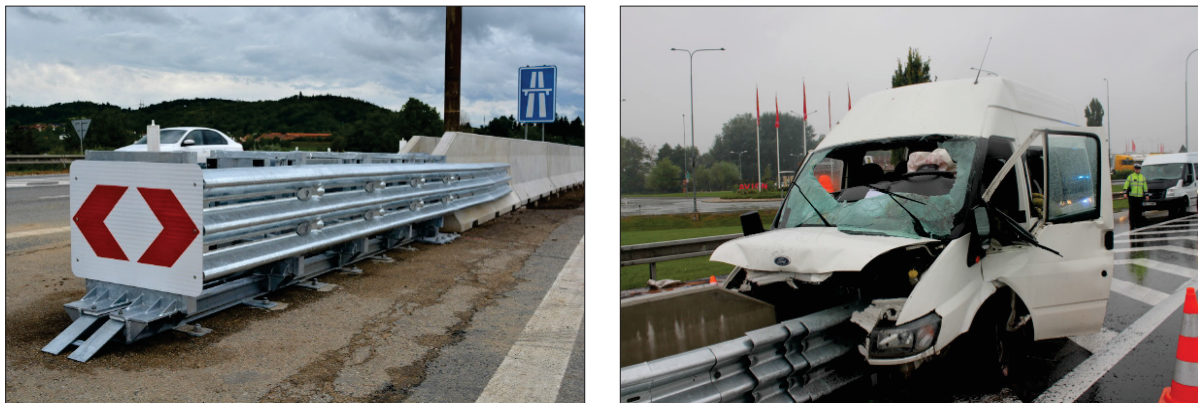
The detailed accident analysis also showed the inadequacy of the installed crash cushion. As illustrated by Figure 1, this type of crash cushion was plugged between the longitudinal beams during frontal collision with small truck. The vehicle engine was pressed into the interior on the front passenger compartment.

Figure 1 Crash cushion (left) [10] and traffic accident of the small truck on the D2 on October 2016 (right)

As a result of the traffic-engineering accident analysis taking account to the medical consequences of the traffic accident, installed crash cushion has been assessed as inappropriate. A crash cushion with the higher retention rate should be installed (at least 110 km/h).

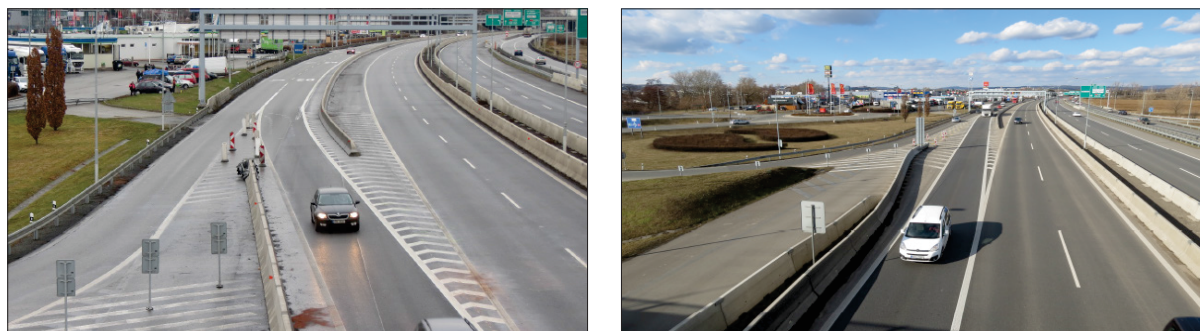
Figure 4 Situation before adjustments (left) and after adjustments (right)

During September 2017, the recommended adjustments has been implemented. The adjustment consisted in the barriers modification, crash cushion displacement, adjusting the horizontal and vertical road marking, installing the transverse thresholds and sounding horizontally marking, the manoeuvring space before crash cushion extending including the lane extension. These adjustments have made the site more comprehensible. The audio-tactile road marking sufficiently alert the driver to the change of direction especially in situations where is driver attention distracted. The crash cushion has been no longer in the straight-ahead direction. There has been no traffic accident since the adjustments have been realized. Compared to the socio-economic losses caused by traffic accidents (2 404 553 Euros), the adjustments realization cost was 406 595 Czech crowns (15 973 Euros)
