5th International Conference on Road and Rail Infrastructure
17–19 May 2018, Zadar, Croatia

Road and Rail Infrastructure V

ON THE IMPORTANCE OF AGGREGATE MINERALOGY IN ASPHALT PAVEMENT DISTRESS

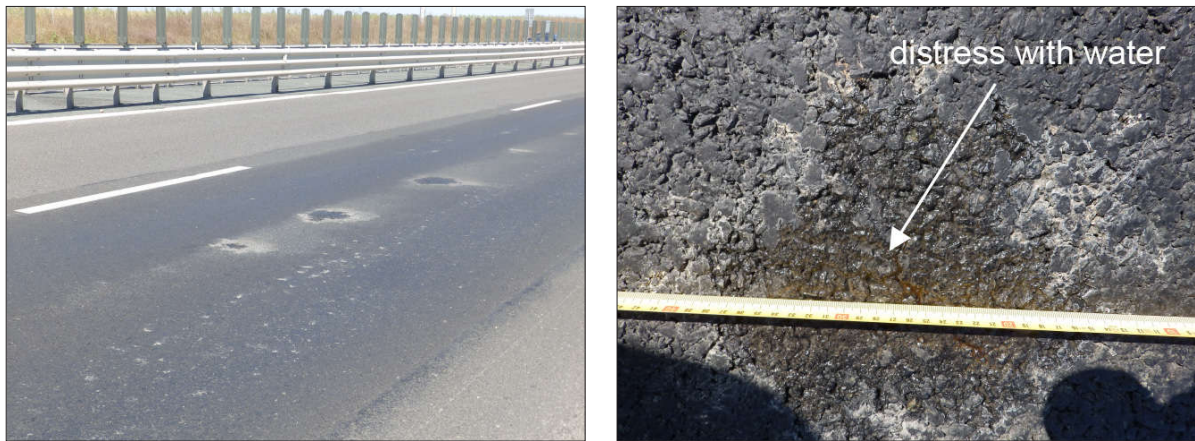
During the past few years, rust-coloured stains were observed on the surface of the bituminous wearing or binder course of several roads and motorways in Romania. In most situations, they were joined by whitish or light-yellow areas (Figure 1, Figure 2). Each of these areas had a surface of approx. 1 sqm. Nonetheless, in some cases they appeared as groups of smaller stains (each with a surface as small as several square centimetres), spread over an isolated larger surface (up to 50 sqm.). The road pavement stains analysed in this paper appear as a fine powder on the surface of both active grains (those forming a skeleton and carrying loads) and passive aggregate grains (those filling the voids in a skeleton and not carrying loads). In some cases, the encountered stains were accompanied by water (Figure 1), although it had not rained recently and the road surface was dry outside the investigated areas. Even in dry conditions (intense sunlight, temperature over 20 °C, no wind, low humidity), water could be identified in some affected areas.

Figure 1 Identified distress

At first, this was an isolated phenomenon and was rather overlooked. However, it quickly evolved to a progressive aggregate stripping process, which, under traffic and weather conditions, led to potholes affecting the pavement. Therefore, it was dealt with by local pavement resurfacing. Nevertheless, the distress not only reappeared soon enough, but it also extended and was identified on many other occasions and sites.

The analysed stains only extend on the surface of the bituminous course and on the surface of coarse and fine grains. This suggests a series of chemical reactions that took place on the pavement surface and led to the formation of secondary minerals. It is believed that the carbonate minerals (mainly calcite) in the aggregate grains react with hydrogen ions resulted as carbon dioxide (CO₂) dissolved into atmospheric water. The newly formed calcite precipitates as the light-coloured thin crust on the surface of aggregates, especially during dry season. Furthermore, the iron sulfides (i.e. pyrite and marcasite) identified in the aggregate grains react in the presence of water and oxygen, leading to a cyclic process involving the formation of sulfuric acid, iron sulfates and water. The resulting acid accelerates the degradation process, including aggregate stripping. These processes were also identified in the case of concrete [5, 6]. According to several sources [7-9], the identified reactions take place with volume expansion, therefore aggregate grains are displaced and potholes are initiated.

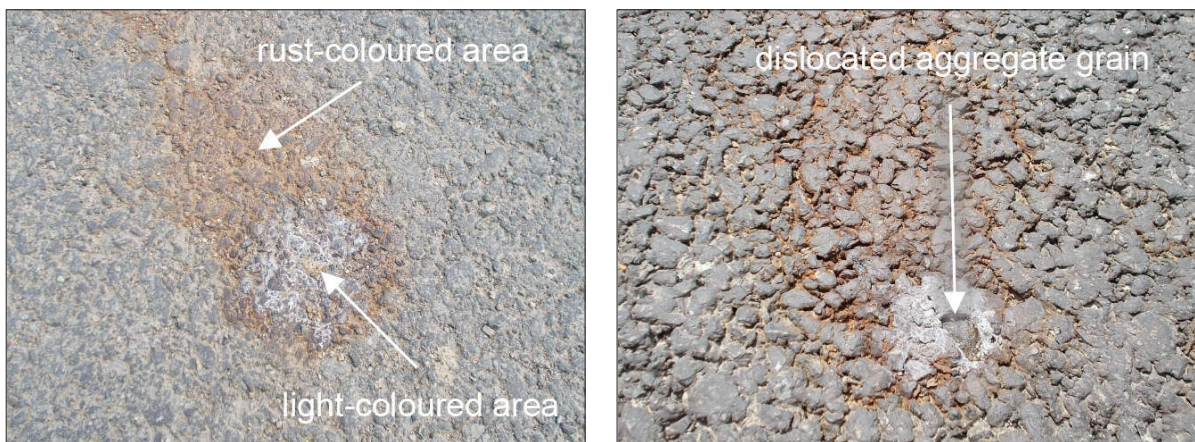
Figure 2 Distress details

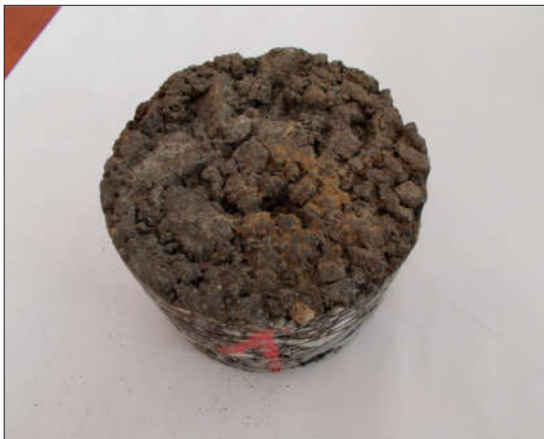
Circular cores (100 mm in diameter) were extracted from the finished asphalt course, both in affected (Figure 3) and unaffected pavement areas from two different sites (Table 1).

Figure 3 Asphalt core sample from affected area

The obtained results have shown that the physio-mechanical asphalt properties in both affected and unaffected areas met the standard requirements, on both analysed sites. The results of laboratory tests performed on SMA materials (i.e. natural aggregates – coarse and fine, bitumen, filler, stabilisers) were also satisfactory.
