## DURABILITY OF REINFORCED-CONCRETE TRACK SLEEPERS

Ivan Zovkić

HŽ Infrastruktura d.o.o., Zagreb, Croatia

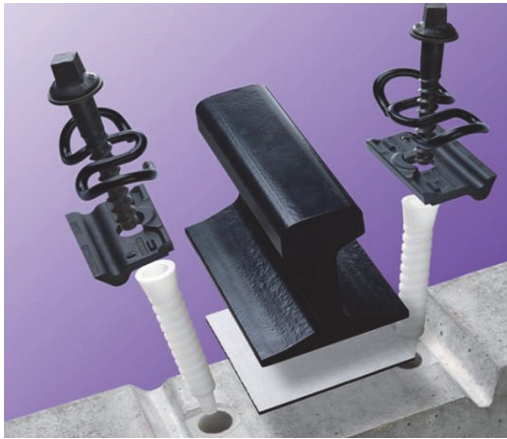
Elastic track fastening device for a prestressed reinforced concrete sleeper consists of: Sleeper screw with washer - 4 pieces, elastic spring clip - 4 pieces, synthetic corner tiles - 4 pieces, synthetic sub-rail pad - 2 pieces, plastic screw dowels - 4 pieces.

Figure 3 Elastic track fastening device for one rail seat section [4]

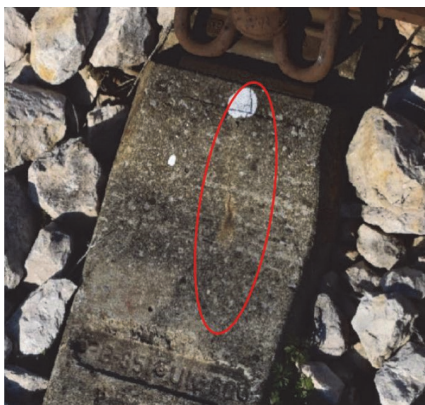
Longitudinal cracks on concrete sleepers due to exploitation have been found on certain railway sections. The railway sections in question have different ground conditions, they are exposed to different climatic conditions and different volumes and types of railway traffic operate on these sections. Longitudinal cracks, which can be found on concrete sleepers, are becoming increasingly common on many railway lines, both in Europe and worldwide. These cracks run parallel to the longitudinal axis of the sleeper between two fixing points. The location where the cracks occur is the position of the plastic dowel. Two types of cracks were identified during the analysis:

- Type 1: longitudinal cracks along the dowels (connection between a rail and a sleeper), maximum in length 30 cm on both sides, width  $\leq 0.5$  mm; the cracks are uneven and non-linear.
- Type 2: longitudinal cracks along the entire length of the sleeper, width  $\geq 1$  mm; the cracks are non-uniform and non-linear

Figure 4 TYPE 1 cracking

Figure 5 TYPE 1 cracking

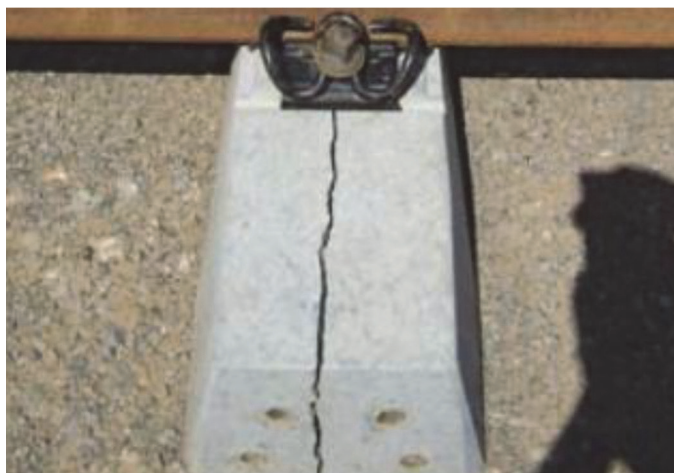
During the reconstruction of the Korint – Tripolis – Kalamata section in 2007, longitudinal cracks were detected on concrete sleepers. As a result, an analysis was carried out and the damaged sleepers were inspected and tested. Most of the cracks had spread over the entire height of the sleeper. They started at the point of attachment and widened towards the end of the sleeper [5]. Figure 6 shows longitudinal cracks on the concrete sleeper along the entire cross-sectional plane.

Figure 6 Longitudinal cracking on the concrete sleeper [5]

After observing the problem, an analysis was performed. After analysis, it was determined that the cause of the cracks was high tightening torque of the bolts. It was proven that a tightening torque of more than 450 Nm in combination with a pre-existing pre-stress can cause the crack in the concrete sleepers and the cracks can occur. It is assumed that the cause of the cracking was the failure of the torque measuring device [5].

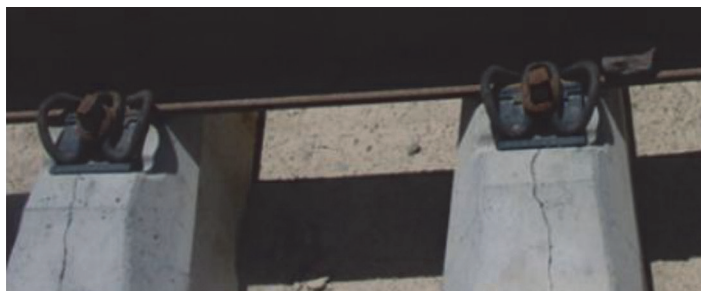
After most of the prestressed concrete sleepers were replaced in 2011, the longitudinal cracks were discovered in the same year. The cracks are found where the screws are, and they widen towards the middle and end of the sleeper. Some of the cracks were noticed before the railway was opened to traffic [6]. In Figure 7, the cracking can be seen at the rail bearing point, i.e. the cracking starts in the dowels that were installed in the sleeper.

Figure 7 Longitudinal cracking in the concrete sleeper

After the problem was discovered, a test was performed on the sleeper, parallel with numerical simulations. After the test, it was found that reinforced sleepers have a higher resistance to longitudinal cracking, as they have better properties than the non-reinforced ones when injected with a larger amount of chemical agents. It was also found that the use of transverse reinforcement bars provided adequate tensile strength to the sleepers. Thus, the longitudinal cracks could be brought under control [6].
