## REHABILITATION OF AN ACCIDENT SPOT WITH HUMAN FACTORS

### Abstract

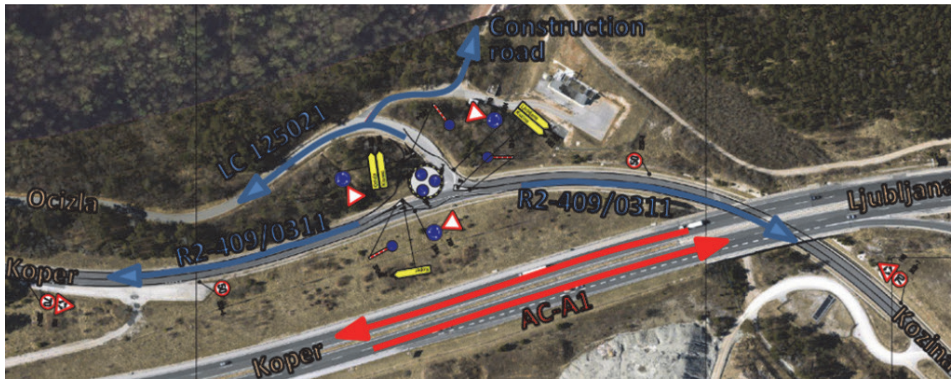
Figure 1 Location of the prefabricated roundabout in R2-409/0311 with signing [1]

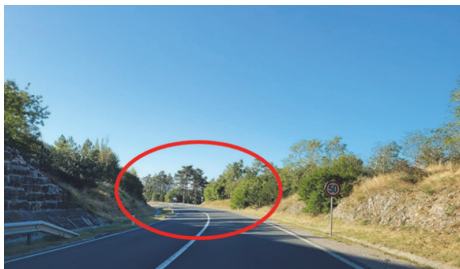
The visibility of the roundabout from East to West is limited as well as the overview about the course of the road. The roundabout is installed more at the right in the direction of the local road direction Ocizla and has a weak visibility. The colour of the prefabricated curbs (yellow - black) almost merge with the surrounding. That’s why the stopping sight distance is not adequate.

Figure 2 Bad visibility of the roundabout and stopping sight distance [1]

Reaction time: The new intersection is located about 300 m after the exit of Kozina in a left curve. It can only be recognized from a distance of about 60 m. Several speed and warning signs try to inform the driver. But it is not installed as an eye-catcher directly in the view axis of the driver. It is rather arranged at the right in the periphery. So the bad visibility provides not enough perception-decision-time to cope with the situation. Only 29 % of the Human Factors requirements are met. The accident probability is high and it is mandatory to take efficient countermeasures.

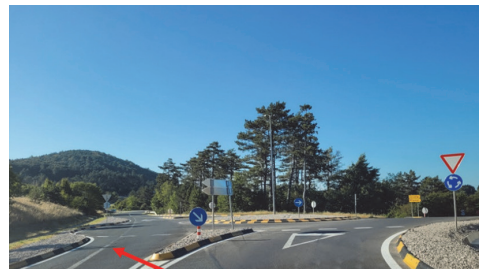
Figure 3 Old misleading centerline [1]

The old centreline, running in the middle of the old left curve was not completely erased. So there is still a perceptible centreline which indicates a left curve instead a right turn entering the roundabout. It has a misleading effect.

<p>The misguiding centre line of the left curve will be completely removed.</p>

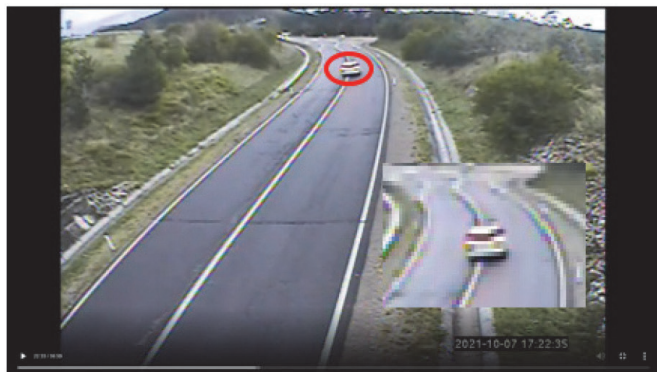
From 6<sup>th</sup> to 8<sup>th</sup> October 2021 a traffic monitoring with a video camera was conducted with a statistical analysis of the driving position, the braking and irregularities in the trajectory (156 vehicles). While approaching the roundabout from the direction of Kozina we observed that 42 cars (27 %) are driving too close to the centreline. Additionally 22 cars (14 %) drifting

dangerously close to the centreline and even 14 cars crossed it (9 %). 96 cars (62 %) started breaking very early because their speed was too high to cope with the unexpected situation. This is a clear hint that the bad visibility of the roundabout and the misleading effect of the centreline works in general and leads to misperception and driving mistakes. It causes for field-dependent drivers a heavy misorientation. So 50 % of drivers interfere with the traffic of the opposite lane. This is completely unacceptable from the point of view of traffic safety.

Figure 5 Driving across the center line [17]
