EFFECT OF BALLAST POCKETS ON DECREASE IN BEARING CAPACITY AND STABILITY OF GEOTECHNICAL RAILWAY STRUCTURES

Pero Šiša, Željko Sokolić
Geotehnički studio d.o.o., Croatia

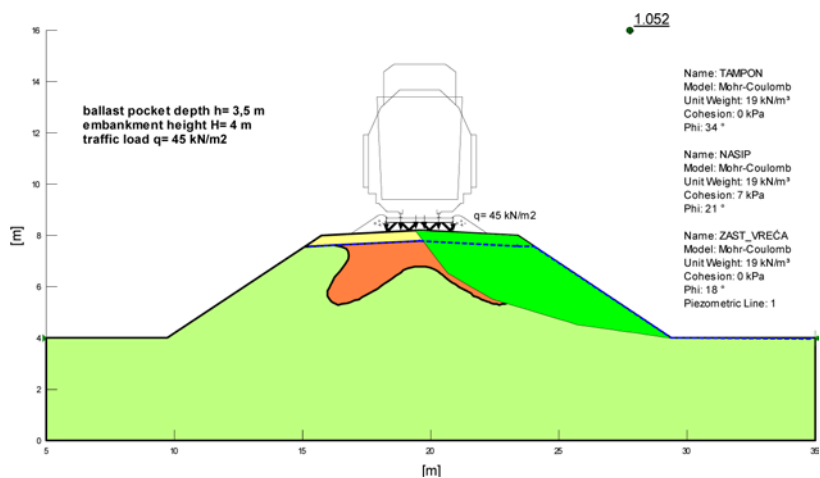
Figure 3 Geo-statical model

Stability analyses conducted on a simple geo-static model (Fig.3.).

Shear strength parameters used in this model are obtained from laboratory testing of embankment material from Donje Dubrave (shear strength parameters c_l , f_l of clayey material in ballast pocket are obtained by Krey Tiedemann method where strength parameters are tested on a sample at liquid limit). By the effect of water found in the ballast pocket and traffic load, shape and depth of the ballast pocket had changed and safety factors for each of assumed cases were obtained. Dependence of the safety factor reduction on ballast pocket depth is shown on Fig.4.

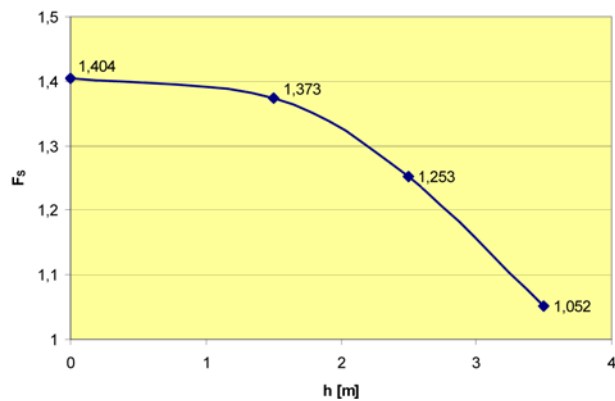
Figure 4 Decrease of safety factor in respect to ballast pocket depth increase

Results obtained from conducted analyses imply following conclusions:

- Increase in ballast pocket size reduces safety factor to occurrence of sliding – failure,
- Reduction of safety factor is not linear. Increment of reduction enlarges when ballast pocket depth reaches approximately 2m,
- Transition to the unstable equilibrium ($F_s < 1,20$) happens when ballast pocket reaches depth of approximately 2,5 m.

Localities on which investigations have been conducted indicate that sporadically in the clayey bedding, ballast pockets of more than 2m of depth are found. Bringing this information in connection with the previously given diagram, it is right to assume that some railway sections are in the condition of insufficient degree of stability to failure occurrence. In practice, reduction of safety factor in an interval from $F_s = 1,1$ to $F_s = 1,0$ is followed with fast increase of deformations ending with failure.
