5th International Conference on Road and Rail Infrastructure
17–19 May 2018, Zadar, Croatia

Road and Rail Infrastructure V

SAFETY INSPECTIONS OF ROADS

Jan Petru, Vladislav Krivda

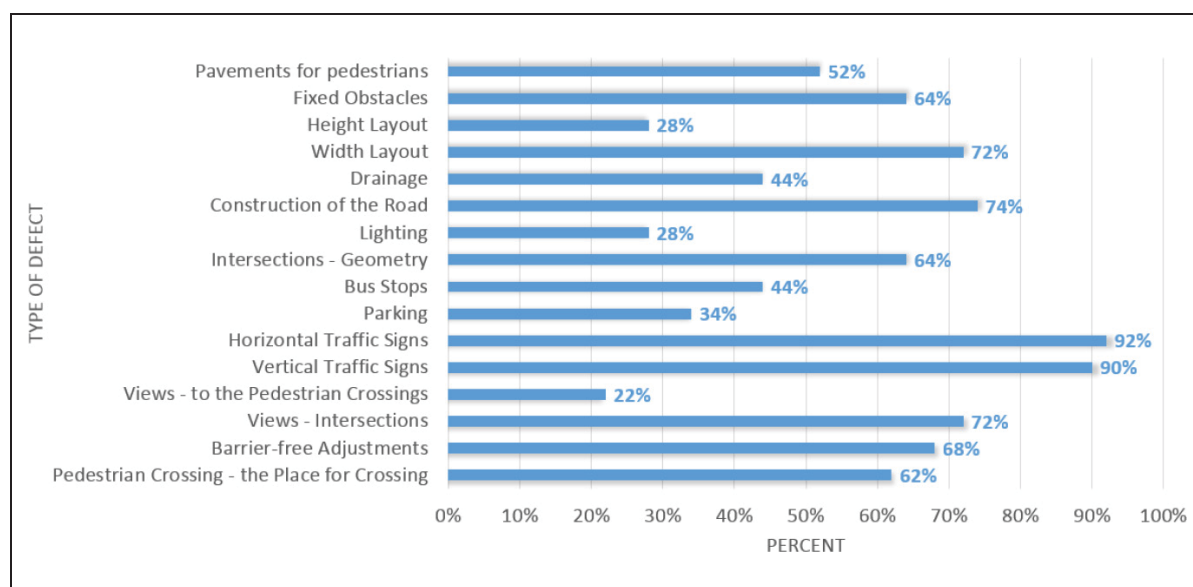
Figure 7 Percentage of identified defects

On the basis of 50 safety inspection that were carried out, the statistical evaluation of found risks with individual percentage of identified defects (risks) was prepared – see Fig. 7. The highest number of risks were found at vertical and horizontal traffic signs – these risks occurred in more than 90 % of inspections. The obstacles in view and not keeping the required distance were also classified between the most serious risks. Further high risks involve no existing barrier-free access, the broad layout of the road and bad conditions of the road construction.
