## THE IMPACT OF WILDLIFE ON RAILWAY TRACK

Slavko Živković<sup>1</sup>, Ivan Barac<sup>1</sup>, Patricia Živković<sup>2</sup>, Ivan Pečina<sup>3</sup>, Bruno Brckan<sup>3</sup>

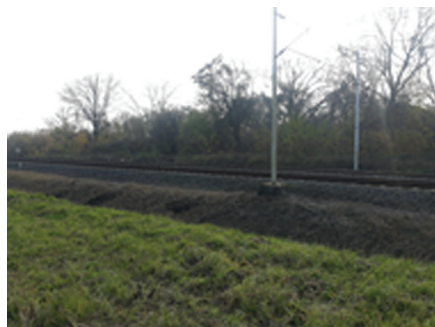
Figure 5 The southern part of the railway line

Unmaintained nature areas are found on the south part of the urban area, between the double track railway line M105 and the regional line R105 within the urban area. On the north side, there are fields and houses. This kind of environment is ideal for badgers and other animals' dens whose natural habitat is the forest and the edges of the forest.

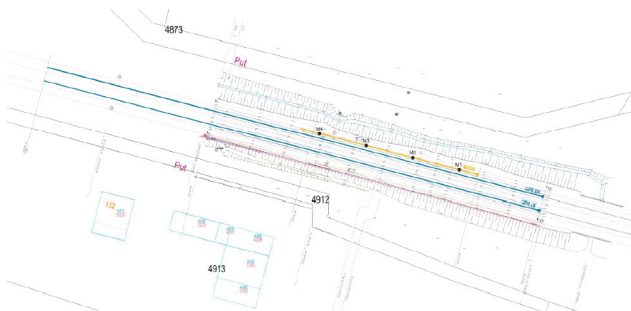
Figure 9 The position of 2D MASW I GPR LT and RT profiles

The position of the GPR LT and RT are shown in Figure 9. The results of GPR are limited to depth of 4 m, so only the embankment is affected by the cross section. It is possible to single out elements that are commonly investigated during GPR measurements on railways in the images.

The reflexes are weak in the area deeper than 1.2-1.4 m. It is difficult to single out the changes, because the embankment is made mainly of clay of relatively low resistance, high conductivity and strong attenuation of electromagnetic waves. The reasons for this can be the already mentioned signal attenuation and the nature of the damage. These are small channels, partially collapsed, with no significant changes in the electromagnetic characteristics of the material, which would lead to strong and noticeable reflexes. On the other hand, seismic MASW method distinguishes the changes in the dynamic characteristics of the embankment that can directly indicate the locations of damage.

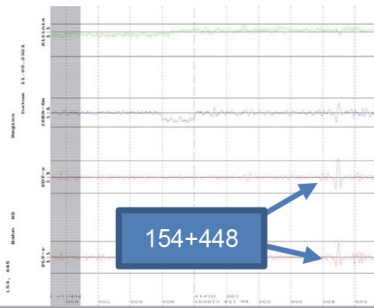
Figure 11 Graphic notation

For category C railways in regular use, 10 represents the limit value for track class for speeds 140-160 km/h, while for category B it belongs to rail class 5 for speeds of 61-80 km/h, or for category A rail class 6 for speeds of 41-60 km/h. The average TQI (Track Quality Indeks) for the km 154+000 to 155+000 is 4.9, the maintenance TQI is 10. The reduction in velocity depends on the magnitude of the error according to the Category C criteria and the estimate of the possible deterioration.
