INFLUENCE OF DIFFERENT PAVEMENT SURFACE ON NOISE LEVELS IN PASSENGER CAR

Stjepan Lakušić, Ivica Stančerić, Maja Ahac

Faculty of Civil Engineering, University of Zagreb, Croatia

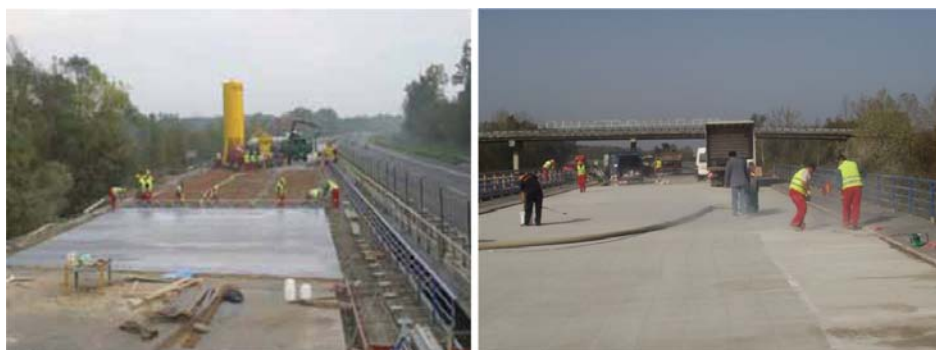
The mentioned bridge was reconstructed in 2004 (northern pavement) and in 2007 (southern pavement), whereby the existing asphalt pavement was replaced by the new, concrete one (Figure 2). Reconstruction was done in such a way that the asphalt layer of the pavement was first milled, and then the deteriorated concrete layer of the base structure was removed hydrodynamically under 2500 bar pressure.

Figure 2 Presentation of works on concrete pavement on Ilova Bridge [3]

On the clean surface of hydrodemolished pavement, the fabric reinforcement Q 283 was laid, and special polymer-modified micro-reinforced concrete c 35/45 was installed, with the thickness of 10–16 cm [4]. Installation of the concrete layer was carried out by the vibratory board which does not have the performances of the device for installation of concrete pavement, so that the evenness of the driving surface was of unacceptable IRI index values. Therefore, leveling of the driving surface of pavement was approached, by grinding and granulating to the acceptable evenness from the aspect of safety [4]. The asphalt-concrete wearing course before and after the bridge was also replaced (after milling) with a new layer of Split Mastic Asphalt (SMA, 16mm). Unlike the concrete pavement, asphalt layers before and after the bridge were installed by a paver.

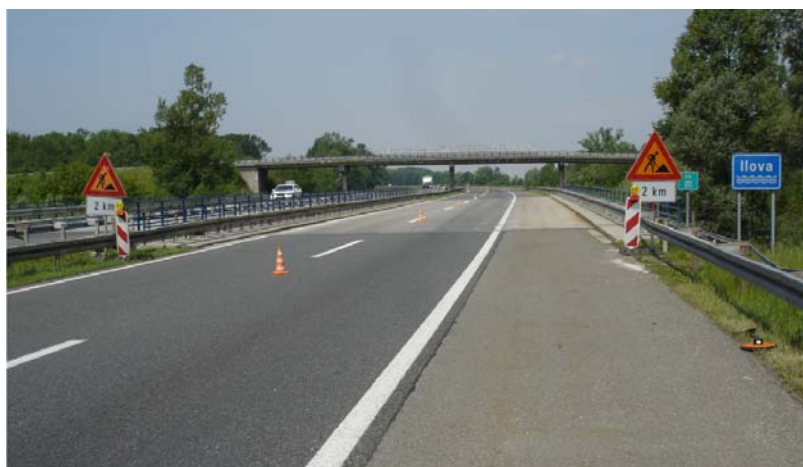
Noise level measuring with the goal of determining riding comfort was performed in the passenger car OPEL Vectra 1.8 16V comfort, with the mileage of 130,000km (regularly maintained on every 15,000km) and equipped with Michelin Energy summer tyres size 195/65/15. The measurements of noise levels were performed in the driver's cab at the co-driver's place by means of the device Bruel & Kjaer Hand-held Analyzer Type 2270, at different movement speeds of the vehicle, from 80 to 130km/h. The test section was only on the northern pavement of the motorway, on the right-hand traffic lane, which was secured by traffic warning systems for the needs of measuring in the length of 600m before and 300m after the bridge, so that the vehicle could move along it without being disturbed (Figure 3).

Figure 3 Test section on A3 motorway

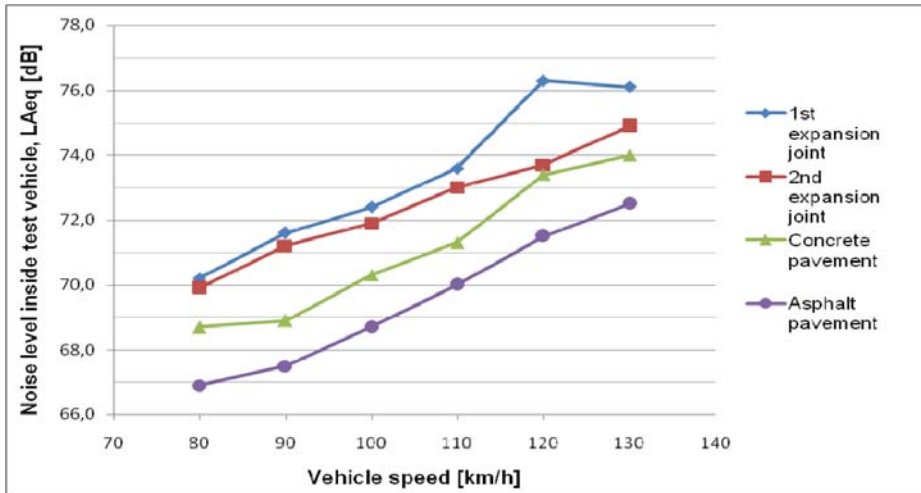
Besides a detailed presentation of the noise levels inside test vehicle with diagrams, Figure 5 shows the relationship between average values of the equivalent (LAeq) noise level in the vehicle depending on the vehicle movement speed, different type of pavement and passage of the vehicle over expansion joints. It is evident from Figure 5 that noise levels inside the vehicle, while driving on the concrete pavement, are by 1.3 to 1.9 dB higher than noise levels while driving on the asphalt pavement, depending on speed. When the vehicle comes across the first expansion joint (transition from the asphalt to the concrete pavement), the noise level is increased by 3.3–4.8 dB, while it increases by 2.2 to 3.7 dB in comparison to the asphalt pavement at the moment of coming across the second expansion joint (Figure 5).

Figure 5 Average noise levels values (LAeq) for different vehicle speed on asphalt and concrete pavement, and over expansion joints

The research showed that, unevenness of the concrete pavement and poorly executed expansion joints result in increased noise levels inside the vehicle. The basic reason for the poorly (unevenly) executed concrete pavement of the Ilova Bridge lies in application of an inadequate technology (vibrating board) for execution of the final layer of the concrete pavement, so that even additional works on the pavement could not have reduced the initial poor execution. Application of an inadequate technology is evidently the consequence of insufficient experience in execution of concrete pavements on roads, since, in Croatia, they are mostly applied at places where vehicles stay for a longer or shorter period of time (e.g. toll stations), where evenness is not so important. Except for increased noise levels, unevenness of the pavement causes higher dynamic loads on vehicles [8], and all that leads to reduced riding comfort and higher maintenance costs for the vehicle and for the road. Positive experience from Austria indicates a need of laying asphalt layers of the pavement in the full thickness on the uneven concrete slab, so that evenness of the driving surface would be equalized along the road, and the effect of slab rigidity during use of the road would be smaller [9]. The execution price of such a pavement structure on road infrastructure structures would be annulled with the time of road using through reduced costs of road maintenance and lower operative expenses of road users. The results of measurements carried out, can certainly be of use in future selection of the pavement structure and the technology of execution on road infrastructure structures, and show that particular care should be dedicated to correct execution of transition devices, all with the goal of safer and more comfortable travelling.
