EVALUATION OF RAIL IRREGULARITIES BY PROCESSING TRAMWAY VEHICLE BOGIE ACCELERATION DATA

Krešimir Burnač, Ivo Haladin

University of Zagreb, Faculty of Civil Engineering, Croatia

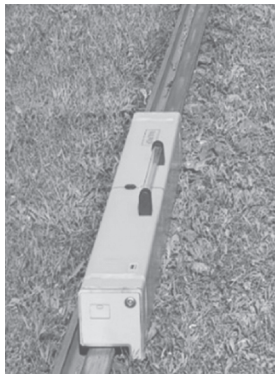
Figure 2 RAILPROF 1000 handheld device (on the left) and rail roughness graphs for locations with different exploitation periods (on the right) in the wavelength domain [4]

To assess the condition of the rail running surface, an acoustic rail roughness measurement campaign was carried out at several locations on the Zagreb tramway track network using a handheld device RAILPROF 1000 [4]. The main focus of measurements was to evaluate rail corrugation according to various exploitation periods and the horizontal alignment of the track (straight line or a curve).
