## NEW CONDITION INDICATOR FOR SIDEWALK MAINTENANCE MANAGEMENT

Carl Van Geem

*Belgian Road Research Centre, Belgium*

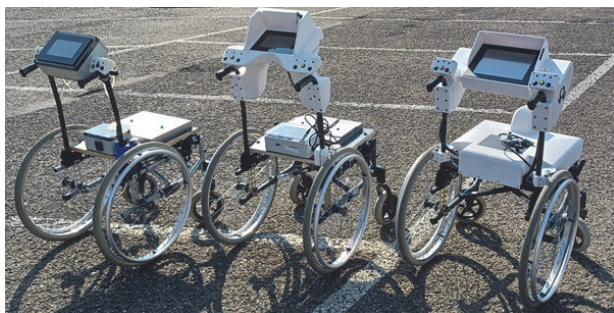
Figure 1 Measuring chair of BRRC

The measuring chair (figure 1) consists of a wheelchair equipped with sensors. The chair is pushed at a near constant speed of 1 m/s (walking speed). The vertical accelerations generated by unevenness of the surface and registered with an accelerometer on the chair are translated into a comfort score on a scale from 0 (uncomfortable) to 10 (perfect). A camera is triggered to take a picture of the surface every 5 m. The accelerometer data are also used to determine gradient and cross-fall of the surface.
